**Marathon Pipe Line LLC, Muddy Creek WRCL 739 Pipeline Maintenance Project, Cumberland County, Illinois;**  
**Conservation Plan for the State-threatened Eastern Sand Darter (*Ammocrypta pellucidum*).**

**Illinois Department of Natural Resources Conservation Plan**  
**(Application for an Incidental Take Authorization)**  
**Per 520 ILCS 10/5/5 and 17 Ill. Adm. Code 1080**

**PROJECT NAME:** Muddy Creek WRCL 739 Pipeline Project

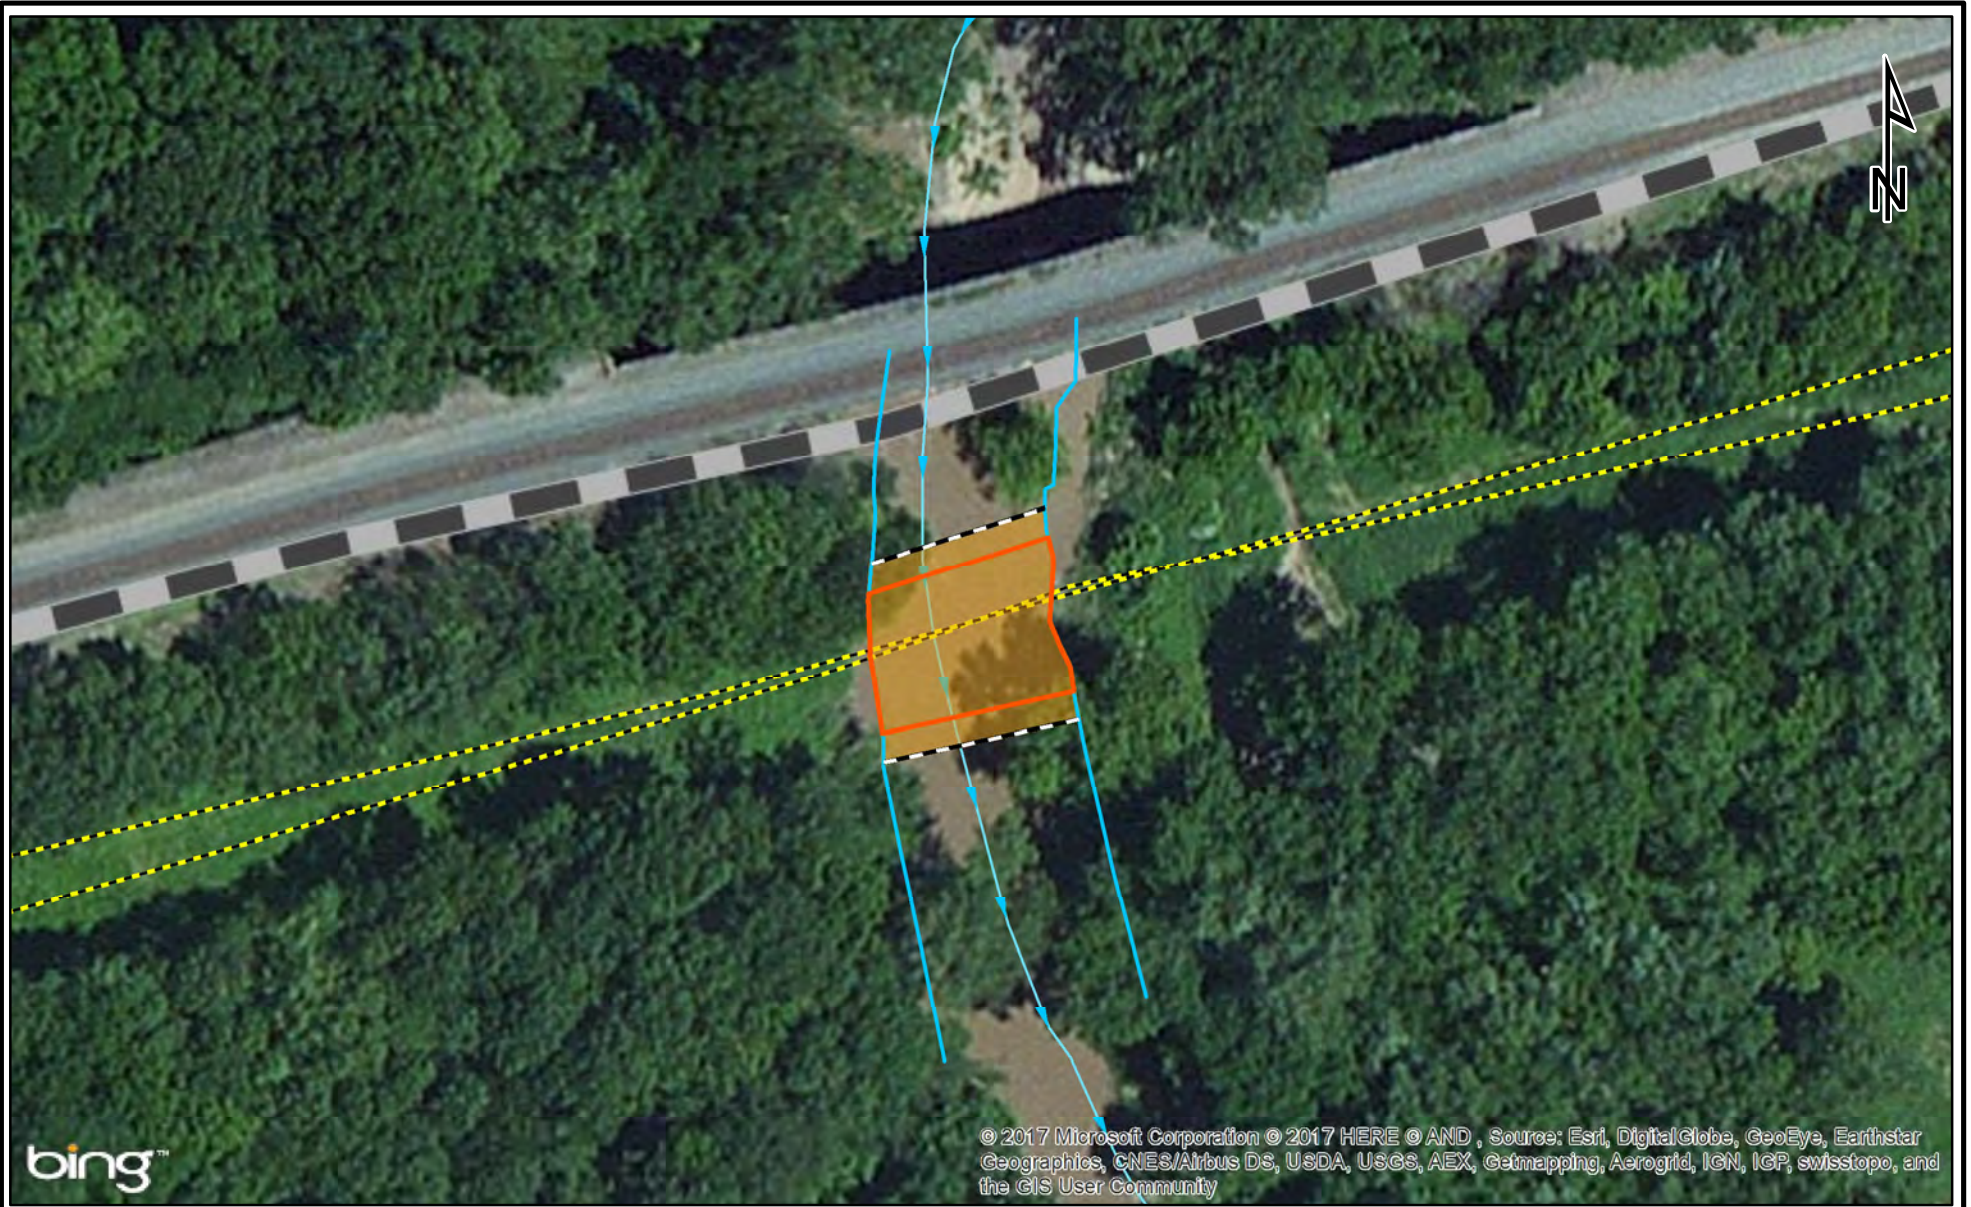
FIGURE  
1

Based on information provided by Marathon Pipe Line Company (MPL), the WRCL 739 pipeline crosses Muddy Creek approximately two miles west/southwest of Jewett, Illinois (Figure 1). The location of the maintenance site is within Muddy Creek at 39.1987° N and 88.2807° W, less than 100 feet south of the crossing of Cumberland Road. The site is approximately one mile east of Woodbury, Illinois. MPL has an active easement with the landowner providing right of way to lay, maintain, operate and remove a pipe line for transportation of oil. A copy of the easement is enclosed as Attachment D. Table 1 provides the property ownership information, address, and legal description of the property.

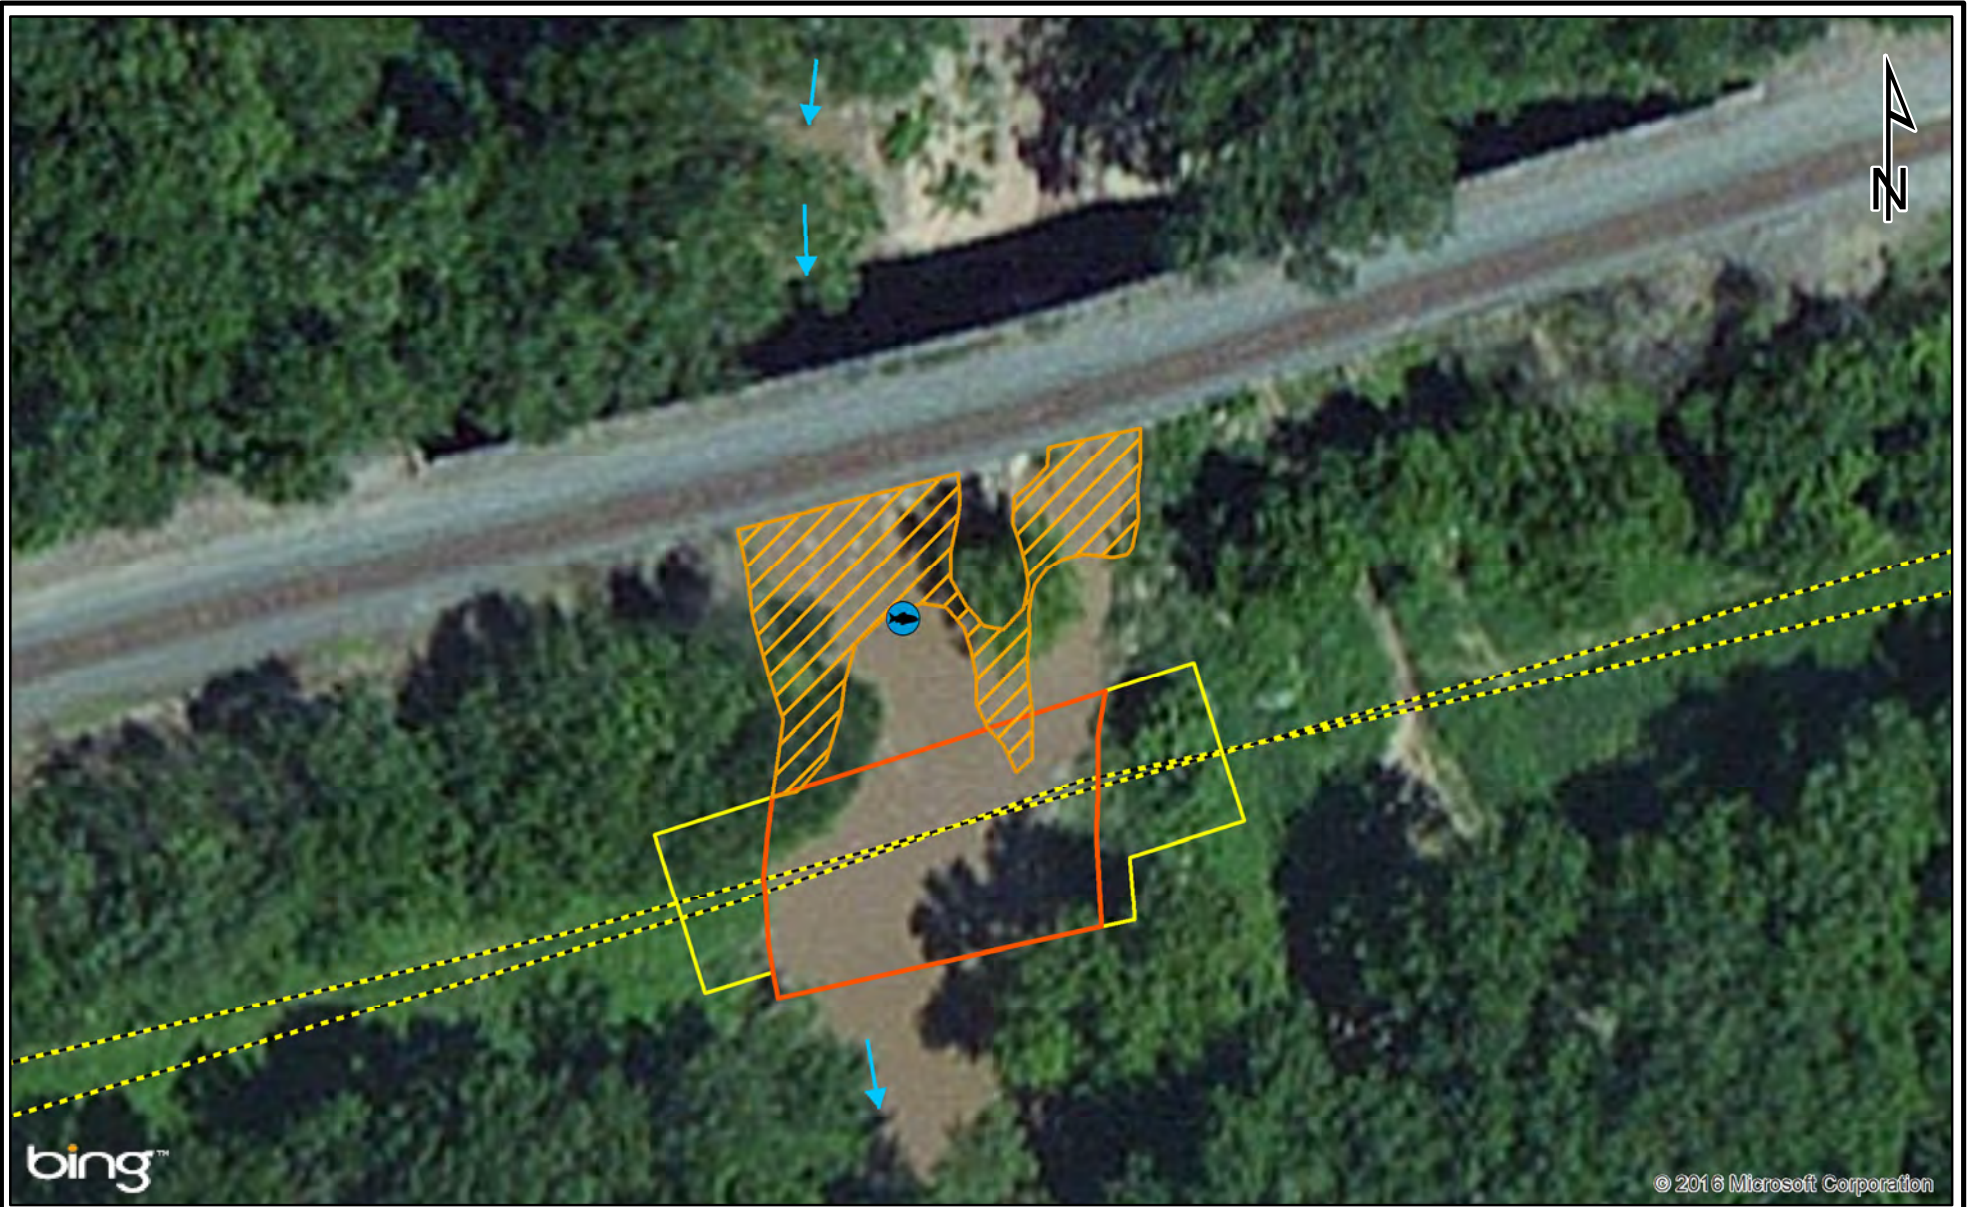
FIGURE  
1

Based on information provided by Marathon, the WRCL 739 pipeline crosses Muddy Creek approximately two miles west/southwest of Jewett, Illinois. The pipeline is currently exposed across Muddy Creek for approximately 69 feet within the ordinary high water mark (OHWM) (**Figure 2**). Marathon proposes to cover and stabilize the pipeline using a geotextile matting system and rock riprap. The area of disturbance within Muddy Creek associated with the proposed pipeline maintenance activities extends 30 feet upstream and downstream of the pipeline centerline, delimiting a 60-foot survey corridor. The OHWM at the pipeline crossing is approximately 69 feet; therefore, the survey area is approximately 4,140 square feet (**Figure 2**).

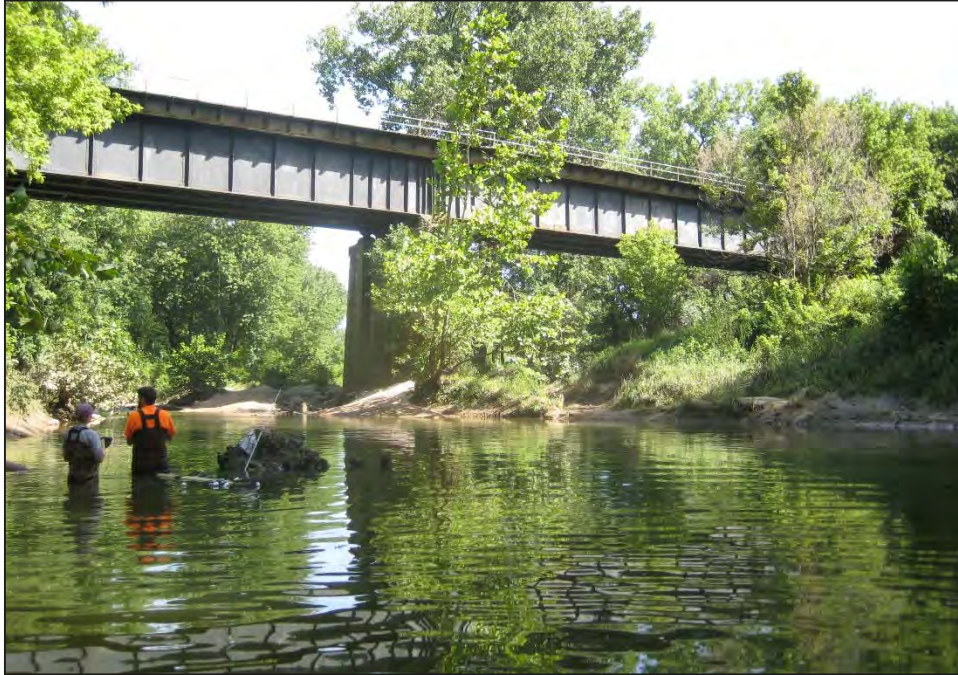
**Photo: 1**

**Description:**  
View of survey area, with adjacent railroad bridge in the background. Facing north (upstream) towards riffle complex and sandbar.

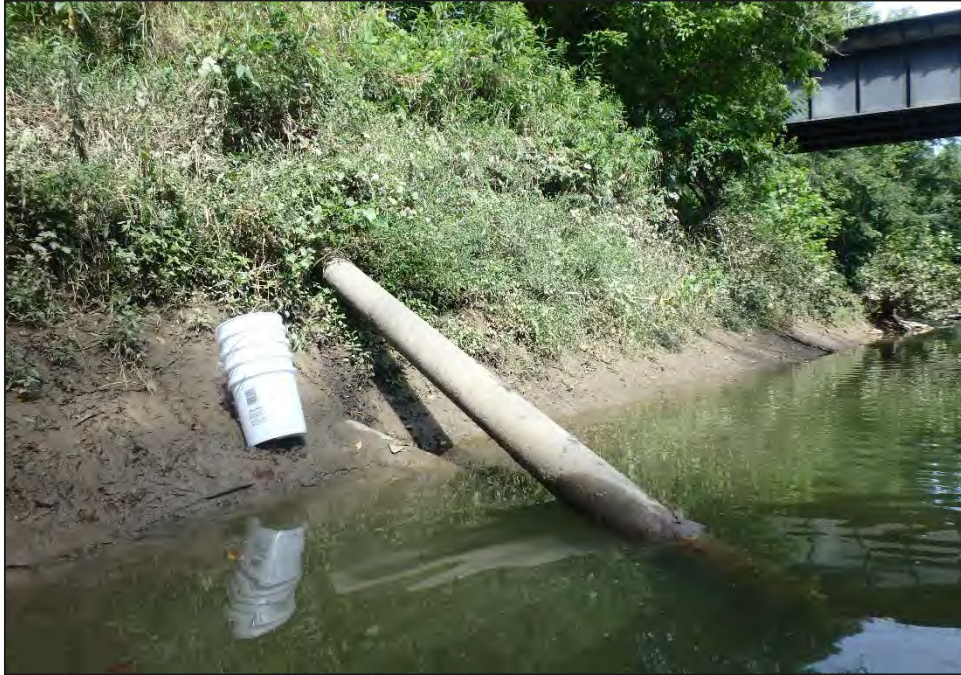
**Photo: 3**

**Description:**  
View of exposed pipeline  
on the right stream bank.  
Photo facing upstream.

The 50-foot wide MPL pipeline right-of-way (ROW) has one 10-inch diameter product line (WRCL 739) that crosses Muddy Creek at Station 5543+68 in Jewett, Cumberland County, Illinois. A railroad bridge is located upstream of the pipeline. The WRCL pipeline is exposed in the creek for approximately 69 linear feet due to bed degradation and bank migration.

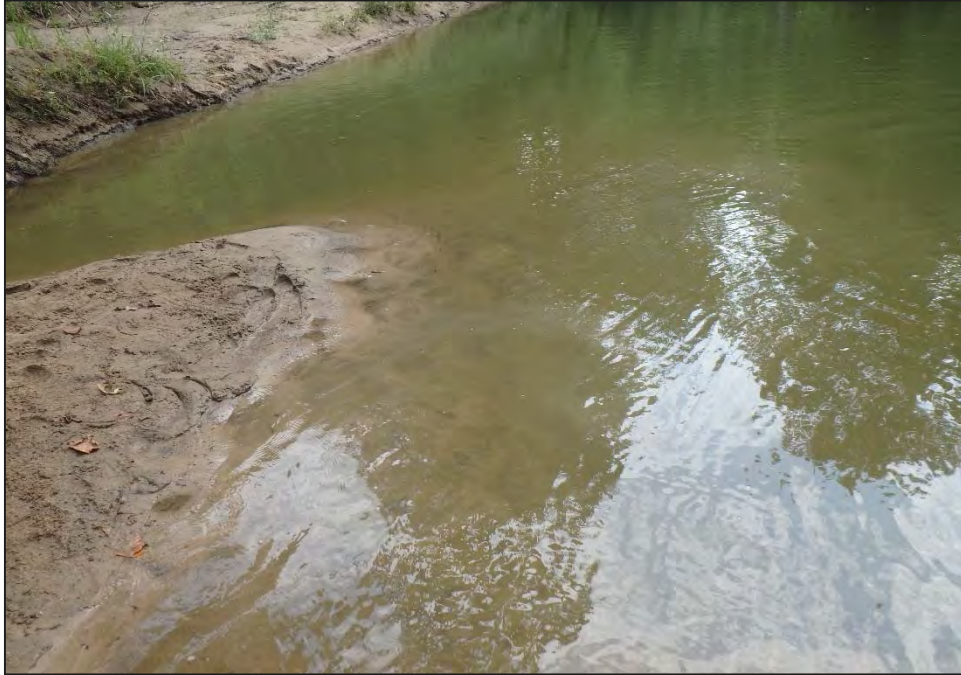
**Photo: 5**

View of in-stream sand bar (gravelly-sand) that extends southward (downstream) into the study area. Photo facing downstream.

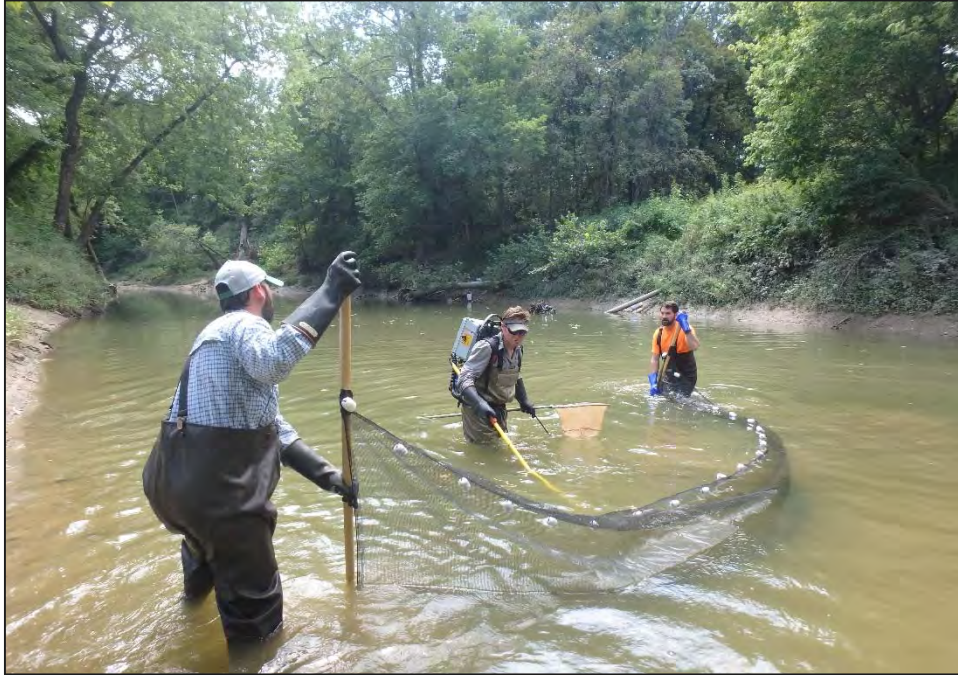
**Photo: 7**

Downstream seining of the sandbar habitat. Per the recommended survey protocol, an electrofisher was used in conjunction with seine hauls to increase collection efficiency.

Electrofishing will be conducted once netting methods have been implemented. To minimize the risk of injury to fish, electrofishing will not be conducted under poor water visibility conditions. Block nets will be monitored for stunned fish that float downstream after being shocked. Arcadis' biologist will ensure that electrofishing attempts use the minimum voltage, pulse width, and rate settings necessary to achieve the desired response (galvanotaxis). Water conductivity will be measured in the field prior to each electrofishing attempt to determine appropriate settings. Electrofishing methods and equipment will comply with guidelines outlined by the NMFS (2000).

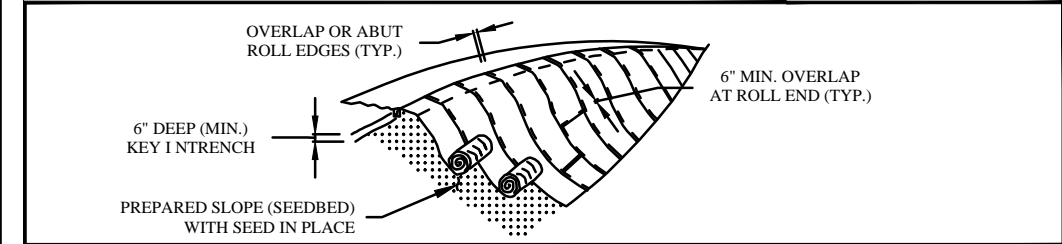
**EROSION CONTROL BLANKET DETAIL**  
SCALE: N.T.S.

- USE TEMP. SOIL STABILIZATION MATTING MADE OF DEGRADABLE (LASTS 6 MOS. MIN.) NATURAL OR MAN-MADE FIBERS (MOSTLY ORGANIC). MAT MUST HAVE UNIFORM THICKNESS & DISTRIBUTION OF FIBERS THROUGHOUT & BE SMOLDER RESISTANT. CHEMICALS USED IN THE MAT MUST BE NON-LEACHING & NON-TOXIC TO VEGETATION & SEED GERMINATION & NON-INJUROUS TO THE SKIN. IF PRESENT, NETTING MUST BE EXTRUDED PLASTIC WITH A MAX MESH OPENING OF 2"x2" & SUFFICIENTLY BONDED OR SEWN ON 2" CENTERS ALONG LONGITUDINAL AXIS OF THE MATERIAL TO PREVENT SEPARATION OF THE NET FROM THE PARENT MATERIAL.

- SECURE MATTING USING STEEL STAPLES, WOOD STAKE OR BIODEGRADABLE EQUIVALENT. STAPLES MUST BE "U" OR "T" SHAPED STEEL WIRE HAVING A MIN. GAUGE OF NO. 11 AND NO. 8 RESPECTIVELY "U" SHAPED STAPLES MUST AVERAGE 1" TO 1-1/2" WIDE & BE A MIN. 6" LONG. "T" SHAPED STAPLES MUST HAVE A MIN. 8" MAIN LEG, A MIN. 1" SECONDARY LEG, & A MIN. 4" HEAD. WOOD STAKES MUST BE ROUGH-SAWN HARDWOOD, 12" TO 24" IN LENGTH, 1" x 3" IN CROSS SECTION & WEDGE SHAPED AT THE BOTTOM.

- UNROLL MATTING DOWN SLOPE. LAY MAT SMOOTHLY & FIRMLY UPON THE SEEDED SURFACE. AVOID STRETCHING THE MATTING.
- OVERLAP OR ABUT ROLL EDGES PER MANUFACTURING RECOMMENDATIONS. OVERLAP ROLL ENDS BY 6" (MIN.) WITH THE UPSLOPE MAT OVERLAPPING ON TOP OF THE DOWNSLOPE MAT.

- STAPLE/STAKE MAT IN A STAGGERED PATTERN ON 4" (MAX.) CENTERS THROUGHOUT & 2" (MAX.) CENTERS ALONG SEAMS, JOINTS & ROLL ENDS.
- ESTABLISH & MAINTAIN VEGETATION SO THAT REQUIREMENTS FOR ADEQUATE VEGETATIVE ESTABLISHMENT ARE CONTINUOUSLY MET IN ACCORDANCE WITH SECTION B-4 VEGETATIVE STABILIZATION.

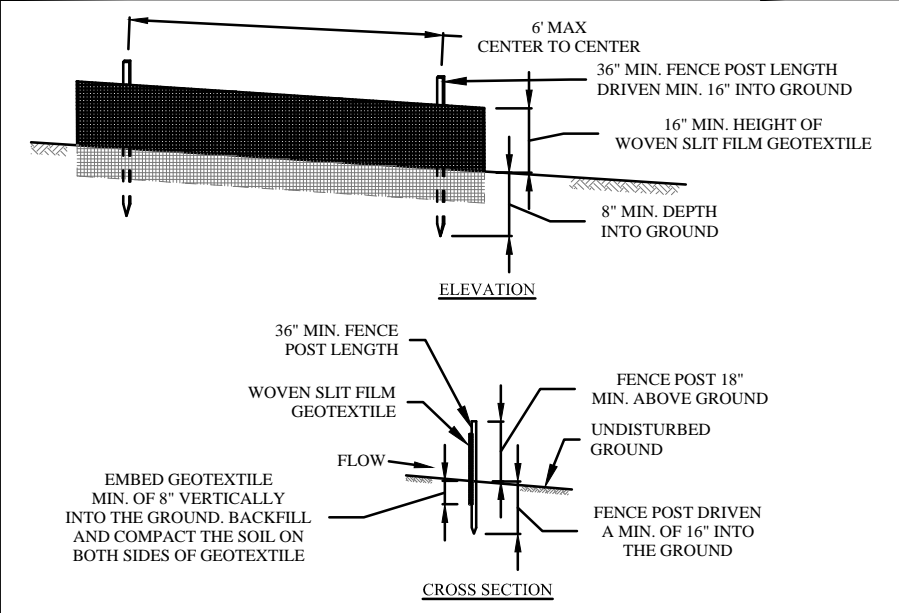
**SILT FENCE DETAIL**  
SCALE: N.T.S.

- USE 36" MINIMUM POSTS DRIVEN 16" MINIMUM INTO GROUND NO MORE THAN 6' APART.
- USE WOVEN SLIT FILM GEOTEXTILE AS SPECIFIED IN SECTION H-1 MATERIALS AND FASTEN GEOTEXTILE SECURELY TO UPSLOPE SIDE OF FENCE POSTS WITH WIRE TIES OR STAPLES AT TOP AND MID-SECTION.

- REMOVE ACCUMULATED SEDIMENT AND DEBRIS WHEN BULGES DEVELOP IN SILT FENCE OR WHEN SEDIMENT REACHES 25% OF FENCE HEIGHT. REPLACE GEOTEXTILE IF TORN. IF UNDERMINING OCCURS, REINSTALL FENCE.

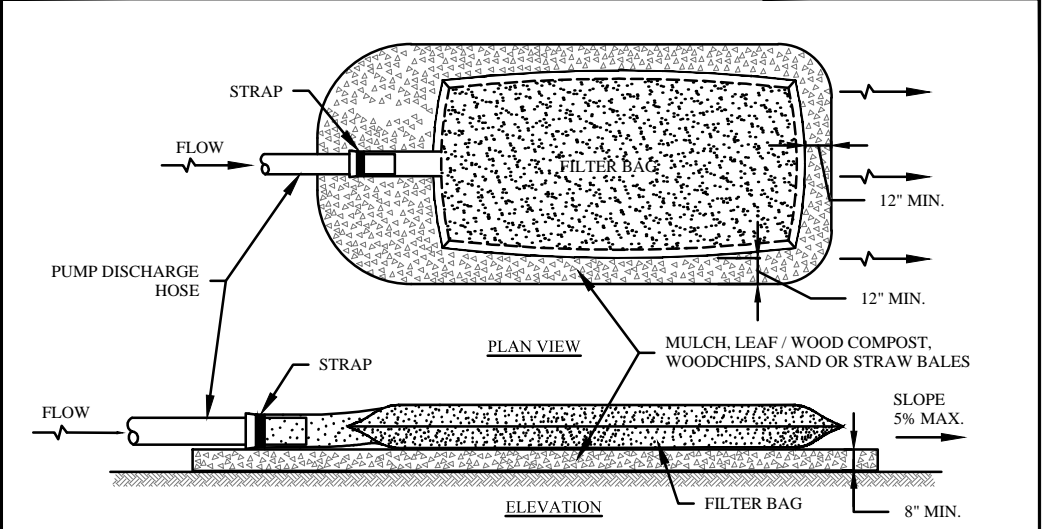
**FILTER BAG CONSTRUCTION SPECIFICATIONS**

- TIGHTLY SEAL SLEEVE AROUND THE PUMP DISCHARGE HOSE WITH A STRAP OR SIMILAR DEVICE.
- PLACE FILTER BAG ON SUITABLE BASE (E.G., MULCH, LEAF/WOOD COMPOST, WOOD CHIPS, SAND OR STRAW BALES) LOCATED ON A LEVEL OR 5% MAX. SLOPING SURFACE. DISCHARGE TO A STABILIZED AREA. EXTEND BASE A MIN. OF 12" FROM EDGES OF BAG.
