Illinois Department of Natural Resources CONSERVATION PLAN

(Application for an Incidental Take Authorization) Per 520 ILCS 10/5.5 and 17 III. Adm. Code 1080

SUBMITTED TO:	Ms. Jenny Skufca Incidental Take Authorization Coordinator Illinois Department of Natural Resources One Natural Resources Way Springfield, IL 62702 DNR.ITAcoordinator@illinois.gov
PROJECT APPLICANT:	Edgar County Highway Department on behalf of Elbridge Township Attn: Aaron Lawson; Edgar County Engineer 12637 East 950 th Rd Paris, IL 61944
PROJECT NAME:	TR 345 over Sugar Creek- Low water crossing replacement County Section 12-04126-00-BR IDOT PMA Seq #21116
COUNTY:	Edgar

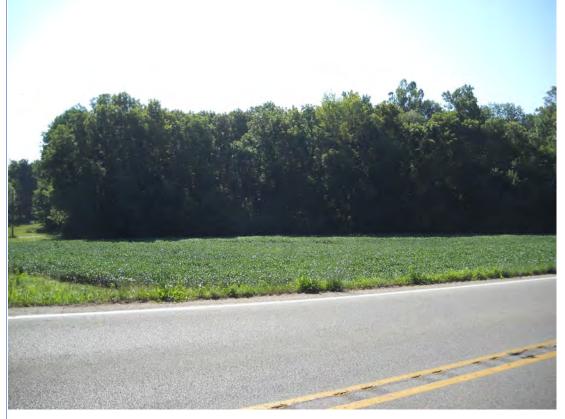
Looking easterly towards salamander habitat that contains breeding ponds

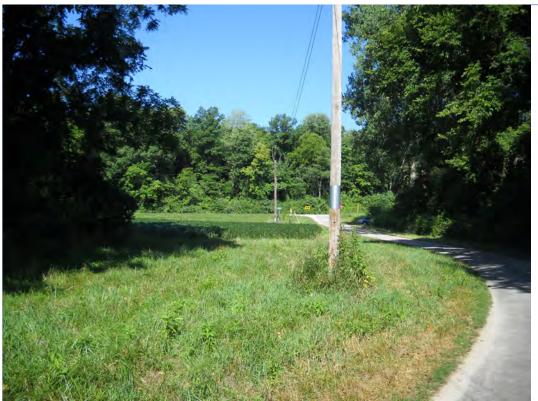
Looking westerly along Staley road from curves. Powerline is approximate location of proposed roadway alignment

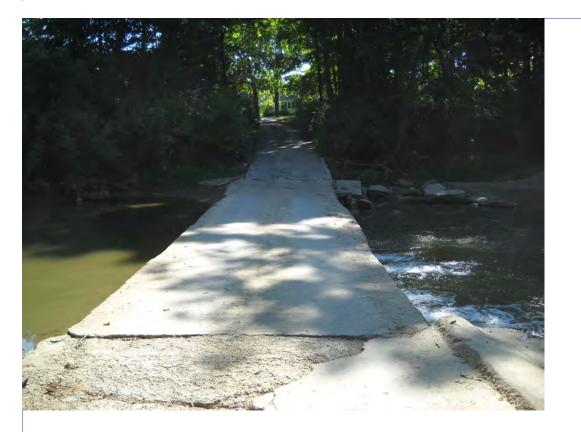
Looking east across low-water crossing

The existing low-water crossing is a single concrete slab approximately 12 feet wide; no thickness information is available. Several corrugated metal pipes are cast in the crossing allowing water to flow through during normal water levels. The low water crossing will most likely be broken up and removed by mechanical means; excavator, jack hammers, etc.

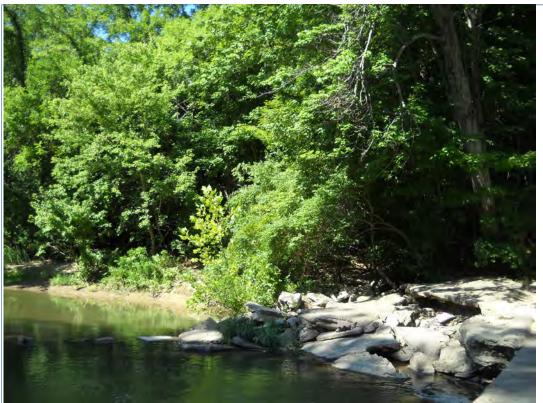
Looking southwesterly from low-water crossing toward salamander habitat that contains breeding ponds south of Staley Road

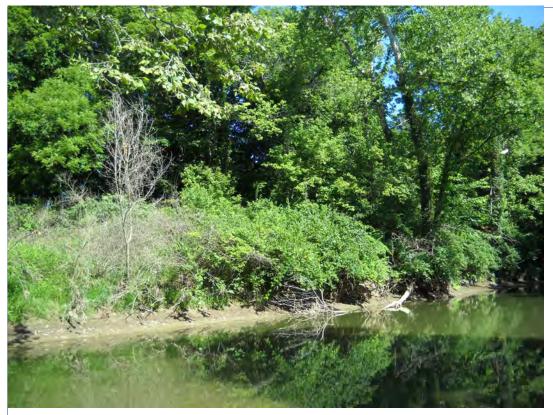
Looking northwesterly from low-water crossing toward salamander habitat north side of Staley Road

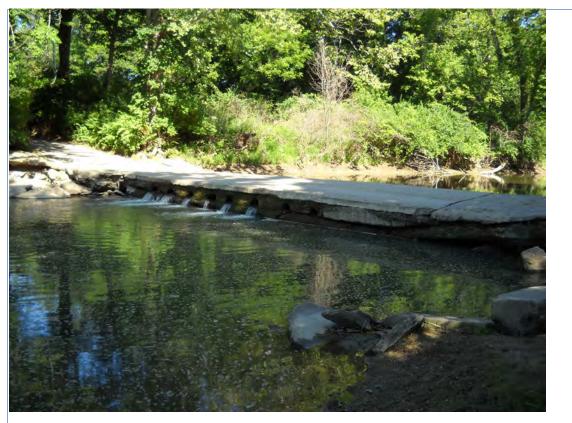
Sideview of downstream side of low-water crossing

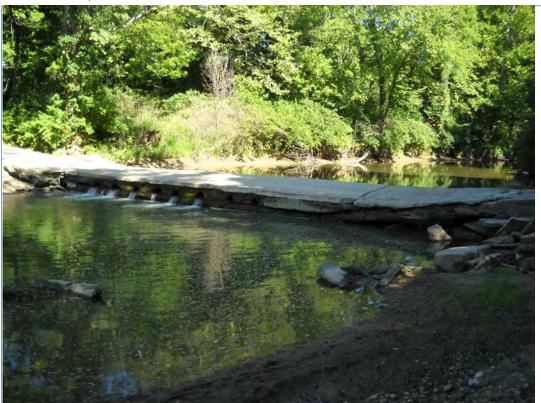
Sideview of downstream side of low-water crossing

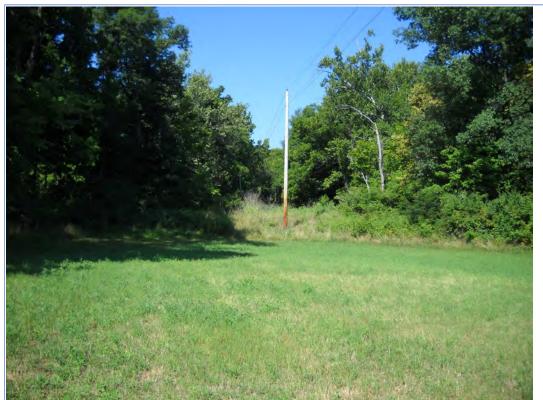
East of low-water crossing looking westerly along powerline easement (approximate location of new roadway alignment)

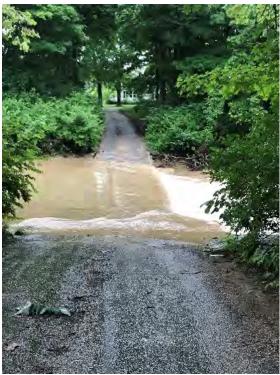
On Staley Road facing east; existing low water crossing (overflow culvert) under water.

The existing structure on Staley Road at Sugar Creek is a concrete slab/culvert, which appears to be near or at grade, and is designed as a low water crossing. Given this design, the structure is completely submerged during high flow events. Although the structure may contain openings underneath the concrete slab to allow for water passage, regular and complete inundation of the structure would preclude it from suitable roosting habitat. It is noted that 0.2 inches of rain was recorded on the day of the site assessment, and the structure was completely submerged at that time. Photographs taken on the afternoon of June 26, 2018 document conditions following the 0.2 inch rainfall (Appendix C). Given the likely regular inundation of the structure, it was not found to provide potential roosting sites.

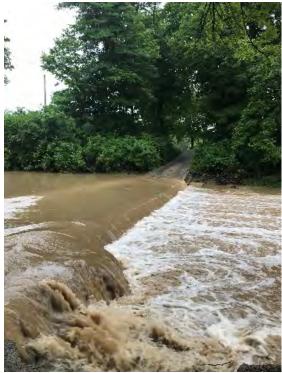
Facing northeast; downstream face of existing low water crossing (overflow culvert).
