Illinois Department of Natural Resources
CONSERVATION PLAN
(Application for an Incidental Take Authorization)
Per 520 ILCS 10/5.5 and 17 Ill. Adm. Code 1080

PROJECT APPLICANT: Macon County
Attn: Bruce Bird, PE, County Engineer
2405 North Woodford Street
Decatur, IL 62526
(217) 424-1404

PROJECT NAME: Rea's Bridge Road Bridge Replacement
Section 14-00268-03-EG
Contract P-97-014-15

A portion of this project is now being constructed as reflected with the submittal of attached plans. The portion being constructed is Rea's Bridge and is a breakout project to replace the two bridges

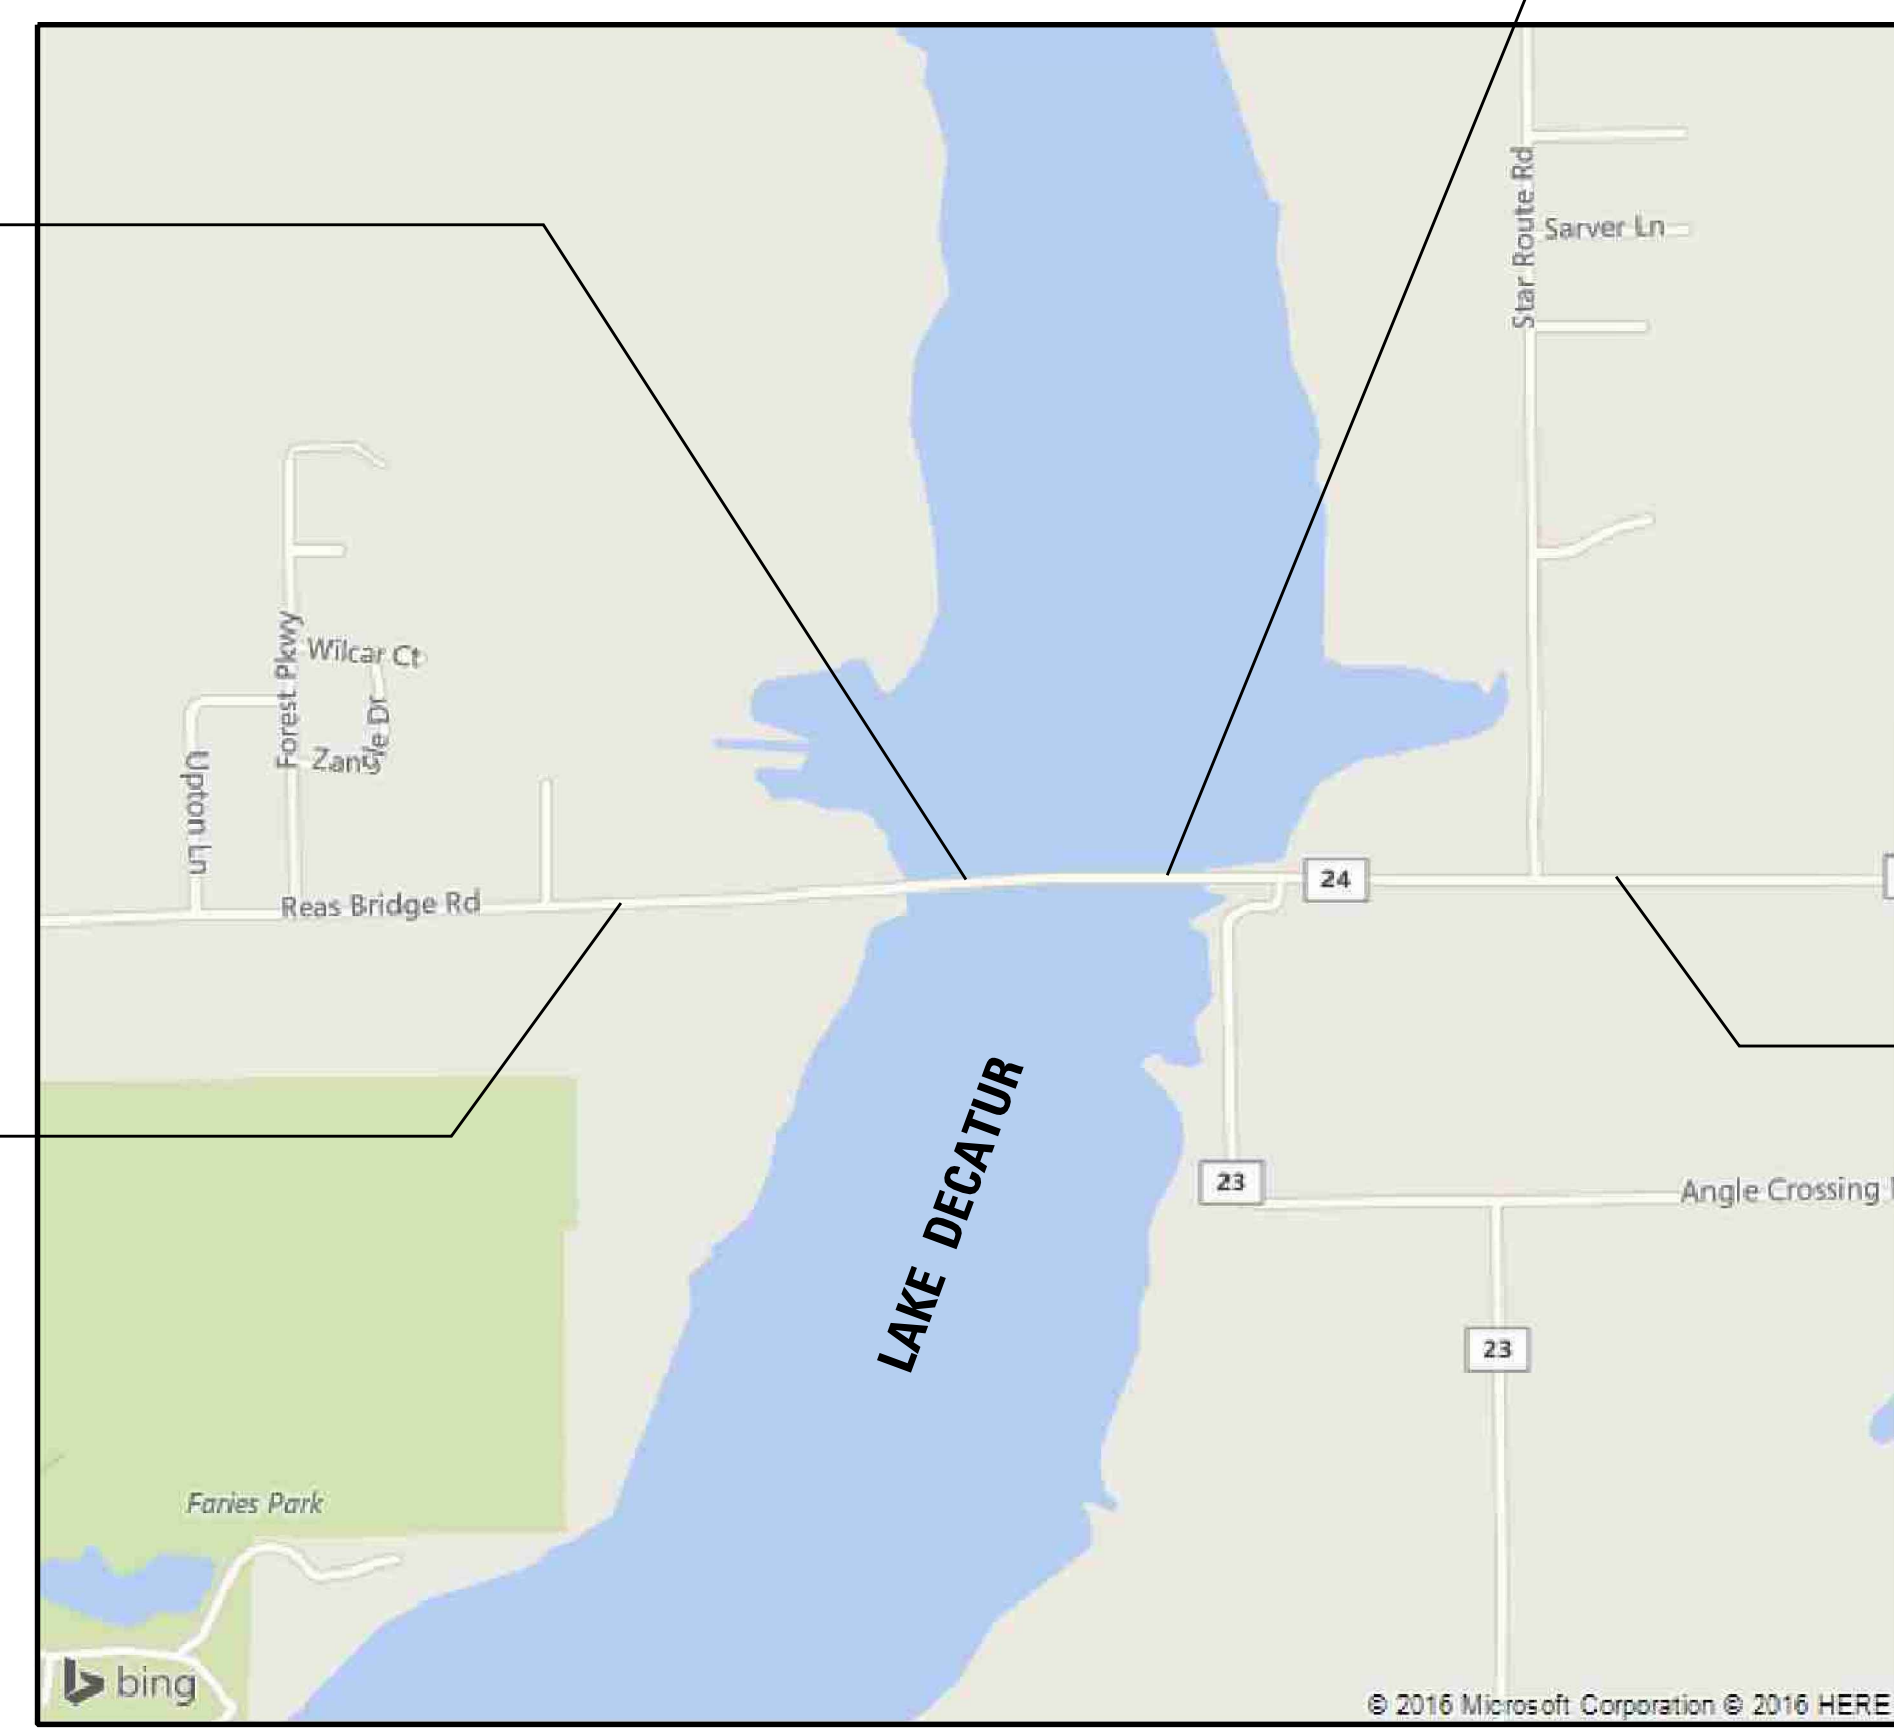
PROPOSED STRUCTURE
STA 44 + 05.50
PROPOSED STRUCTURE NO. 058-3408
EXISTING STRUCTURE NO. 058-3032

PROJECT ENDS
STA 59 + 25

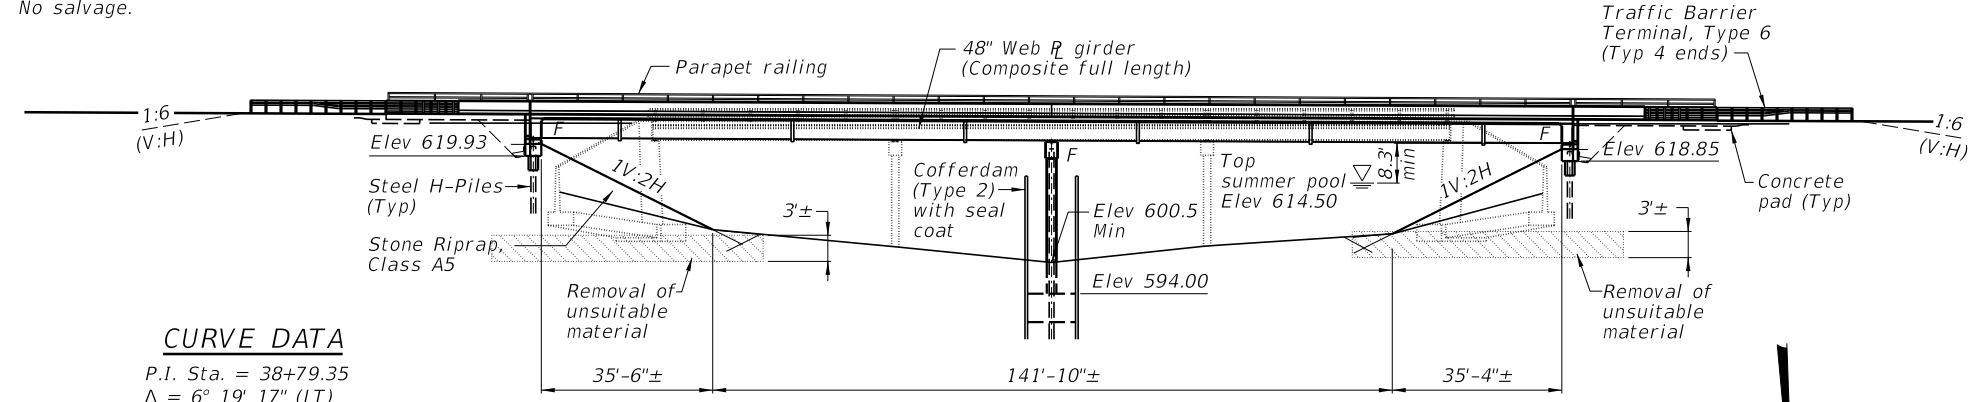
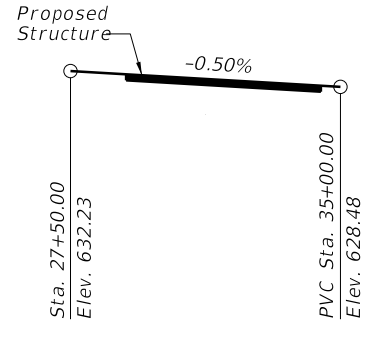
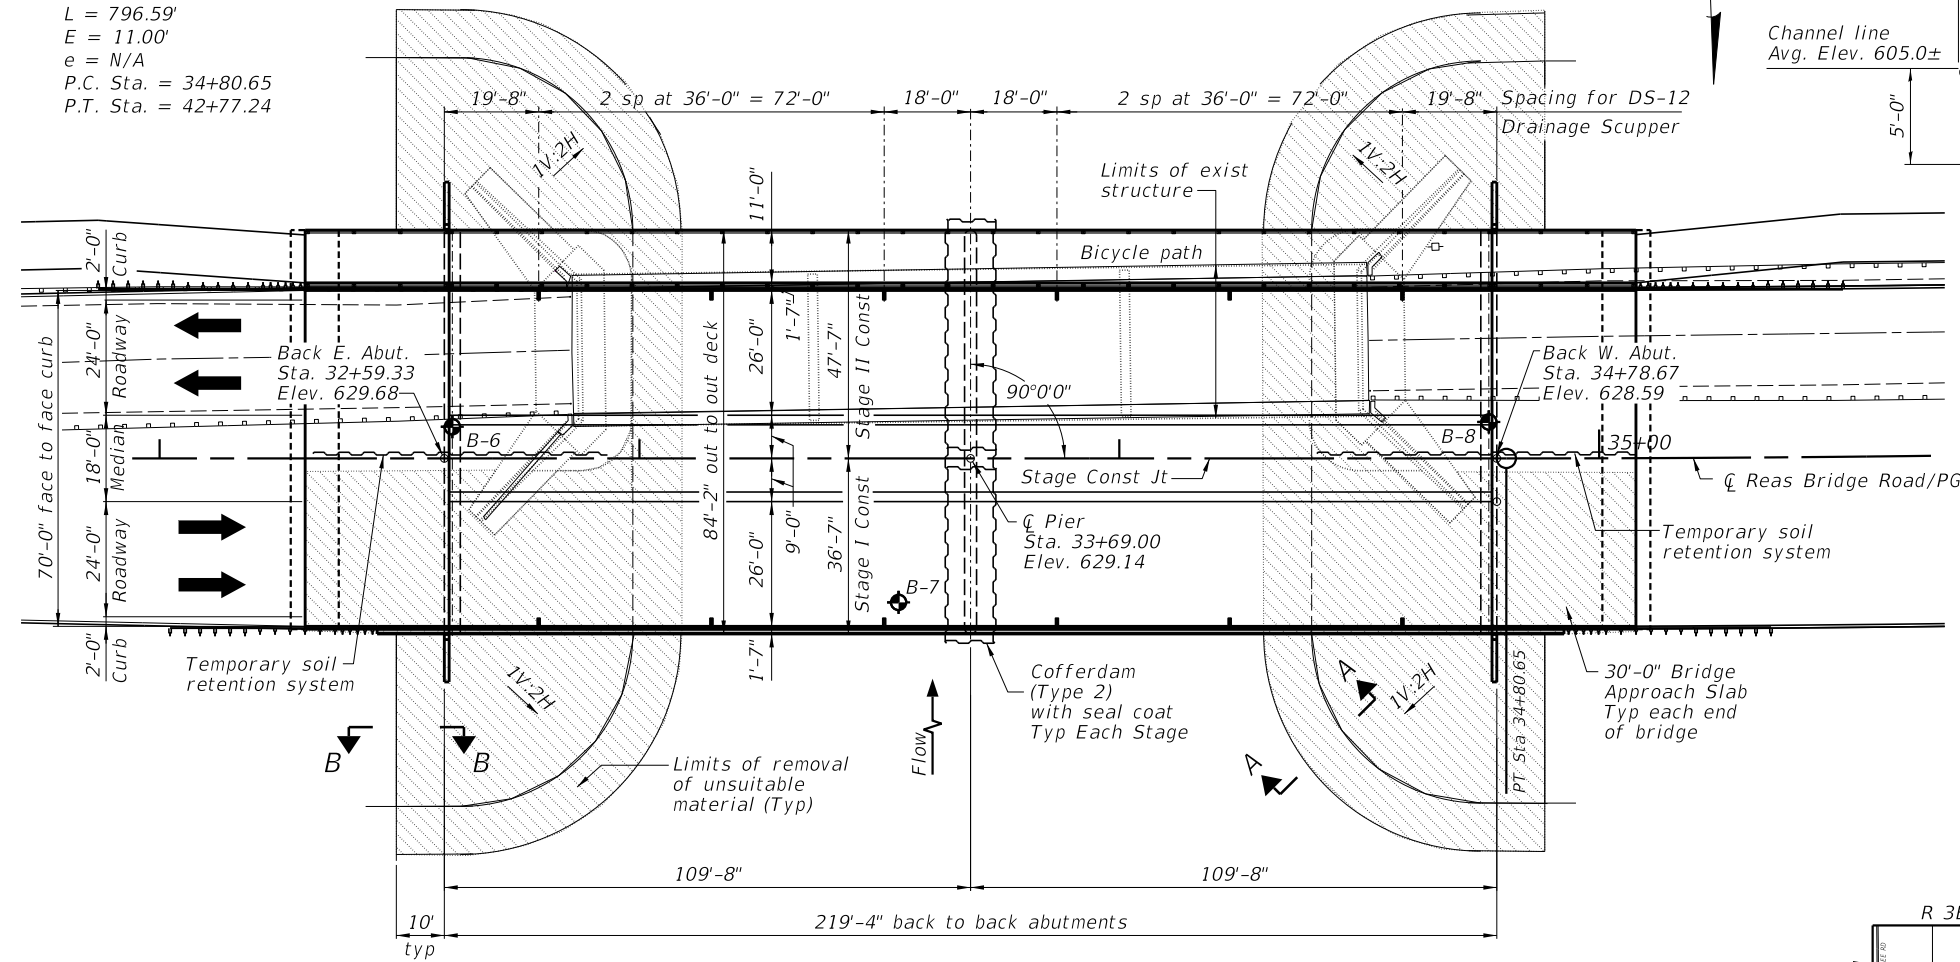
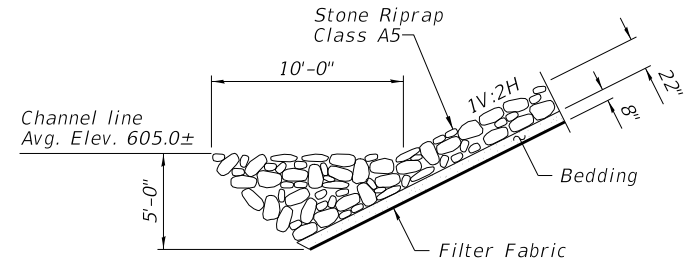
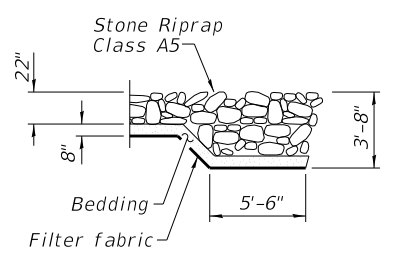
REAS BRIDGE ROAD OVER
 LAKE DECATUR
 BUILT 20 BY
 MACON COUNTY
 SECTION 12-00252-00-BR
 STA 33+69.00
 STR. NO. 058-3409 LOADING HL-93

Event / Limit State	Design Scour Elevations (ft.)			Item 113
	E. Abut.	Pier	W. Abut.	
Q100	619.9	587.9	618.9	5
Q200	619.9	586.5	618.9	
Design	619.9	587.9	618.9	
Check	619.9	586.5	618.9

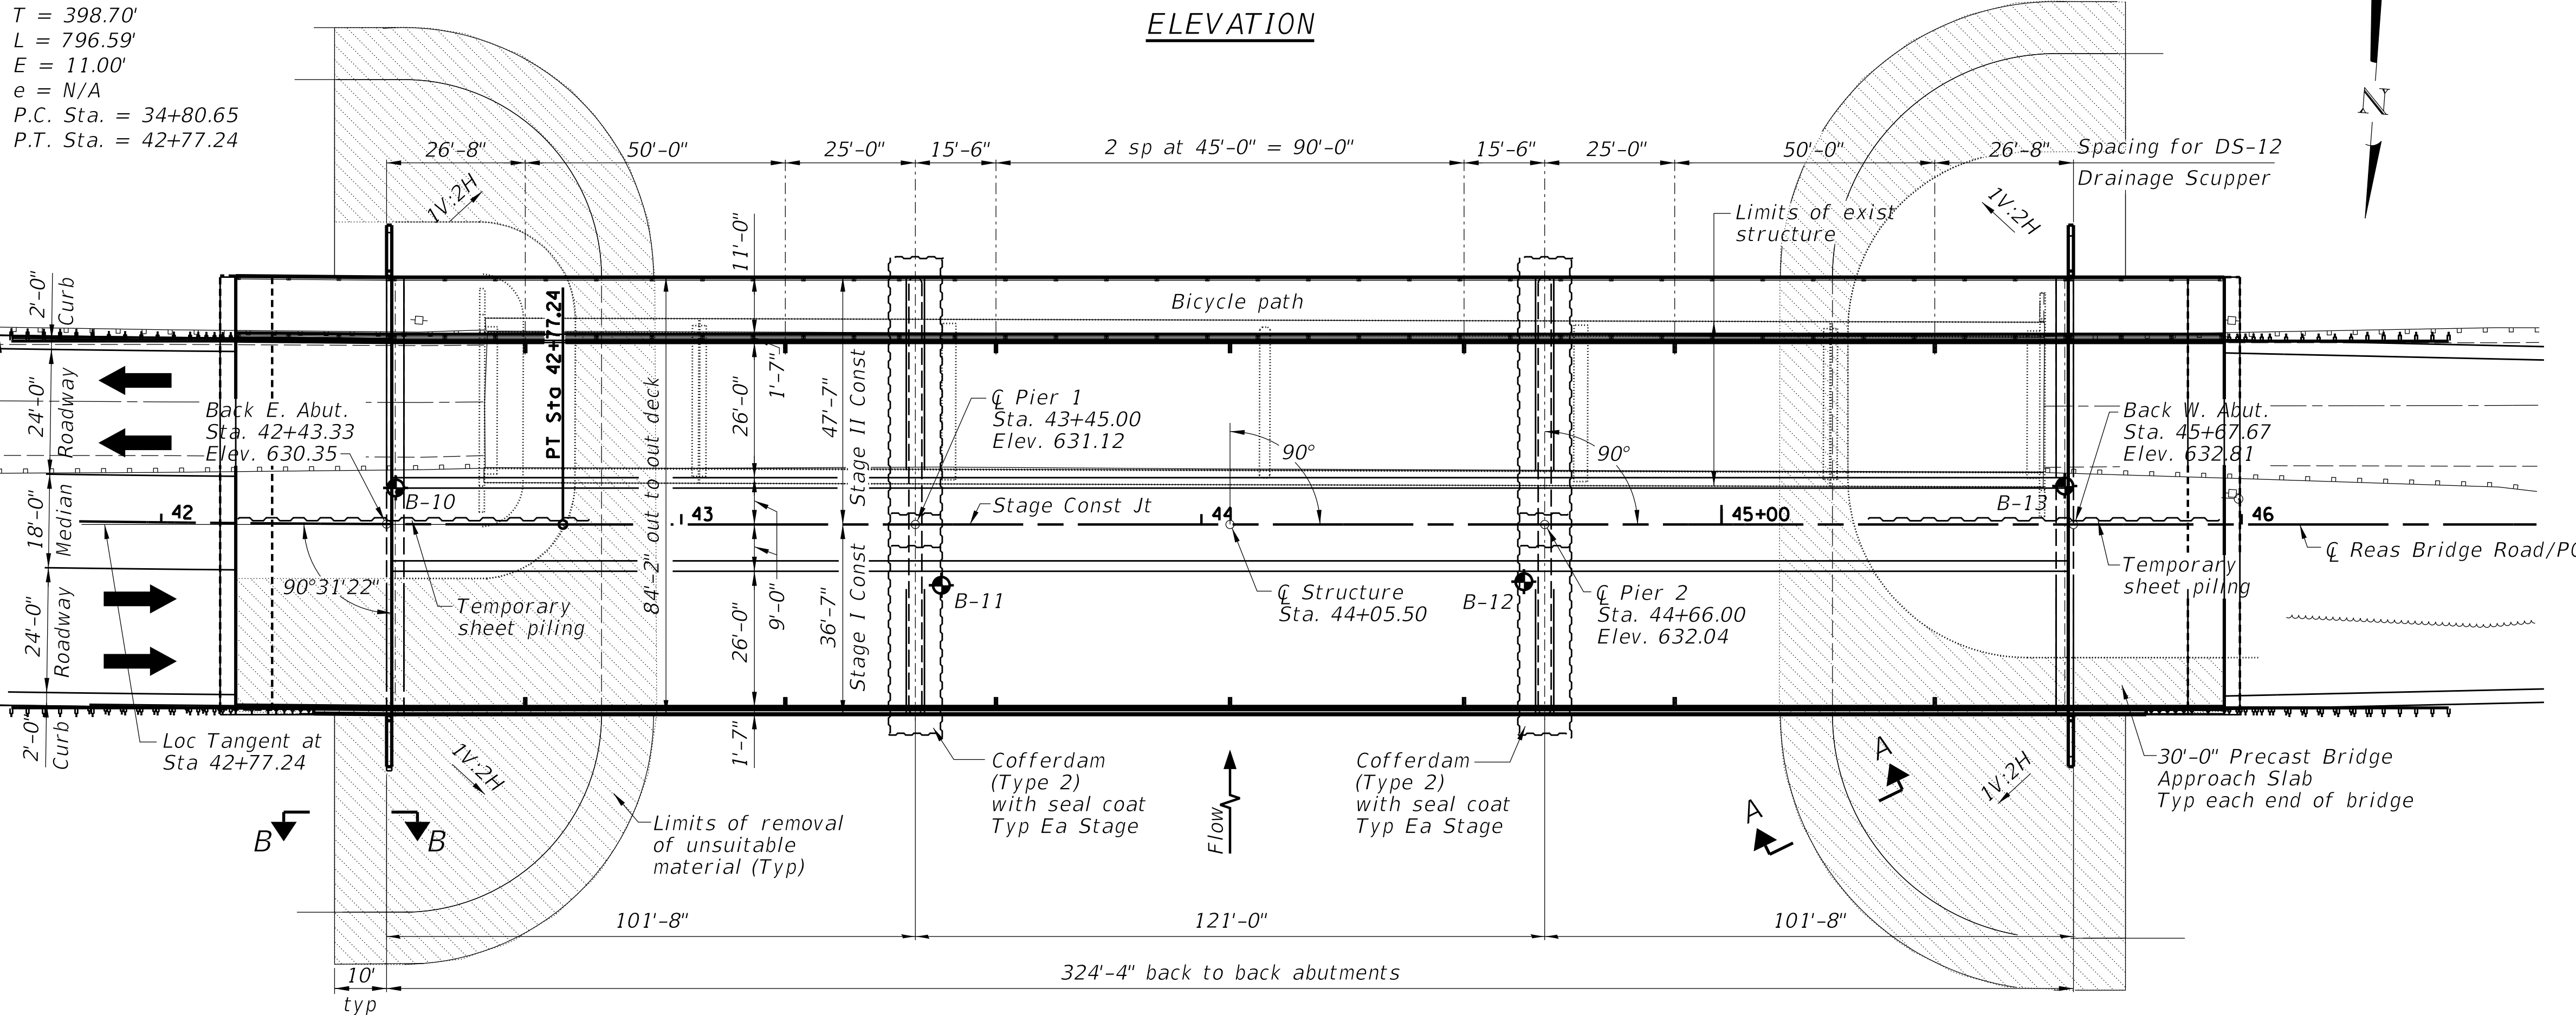
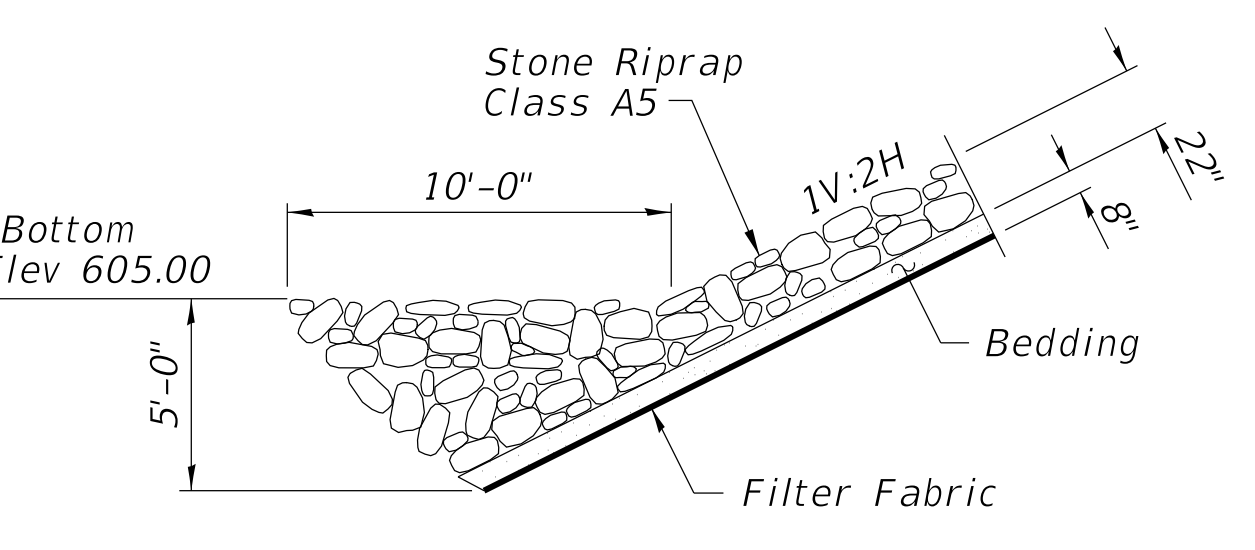
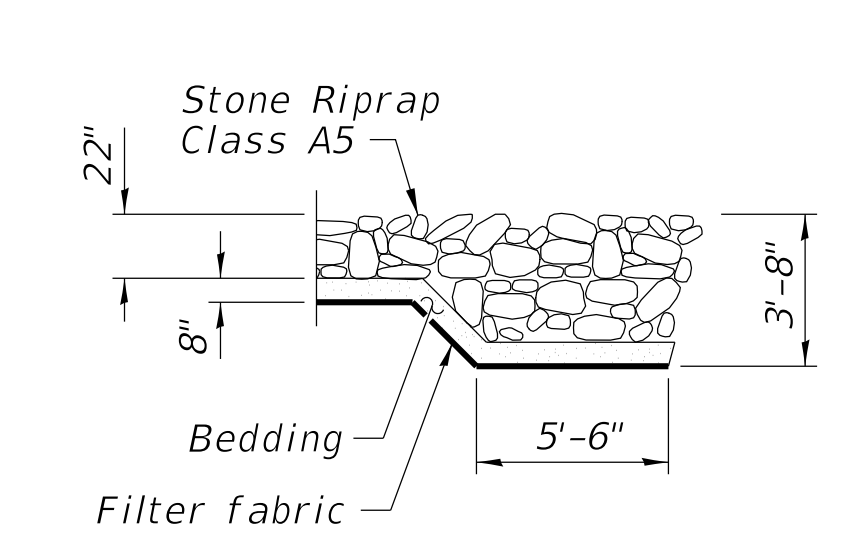
REAS BRIDGE ROAD OVER LAKE DECATUR BUILT 20 BY MACON COUNTY SECTION 12-00251-00-BR STA 44+05.50 STR. NO. 058-3408 LOADING HL-93

Event / Limit	Design Scour Elevations (ft.)				Item 113
	E. Abut.	Pier 1	Pier 2	W. Abut.	
Q100	620.6	590.7	590.7	623.1	5
Q200	620.6	587.8	587.8	623.1	
Design	620.6	590.7	590.7	623.1	
Check	620.6	587.8	587.8	623.1

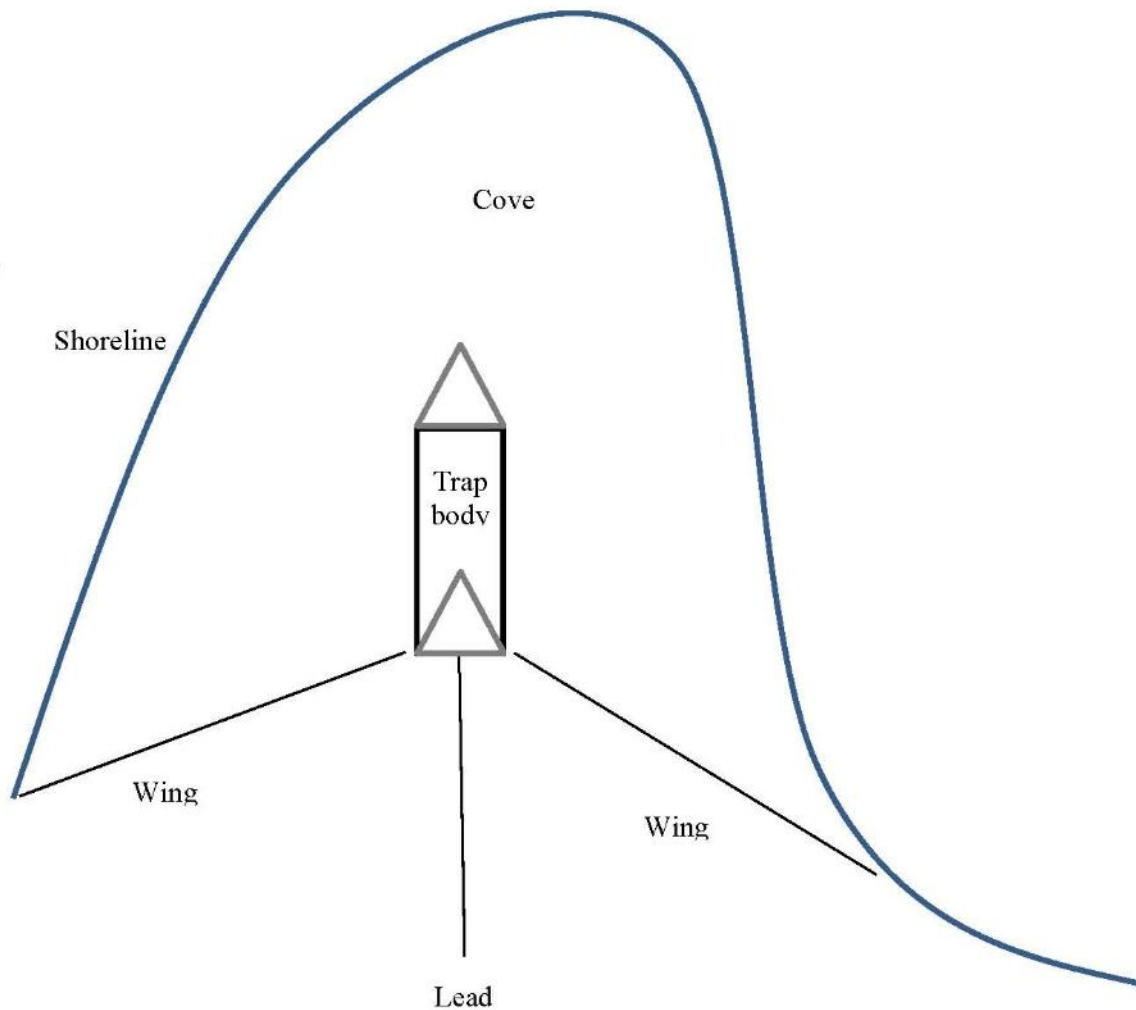
Figure B.1. Fyke Net set to capture turtles attempting to enter a cove (as viewed from above).

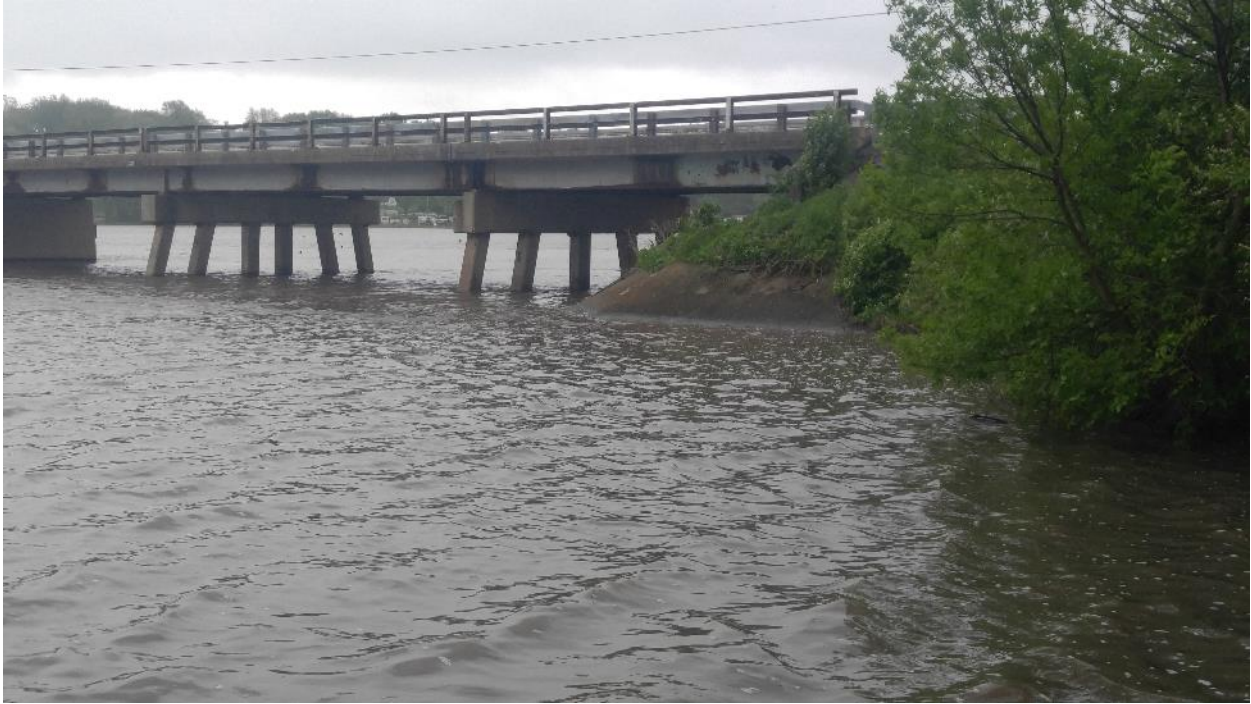
Plate 1. Photograph, looking south from the west side of Lake Decatur towards Rea's Bridge Road (CH 24). The shoreline is poured concrete and there are no loose bank stabilization materials to search under. Photograph taken 20 May 2020 by Andrew R. Kuhns.

The INHS Report included as Appendix (X) states that "The majority of the Environmental Survey Request Area (ESR) consists of lentic Lake Decatur. There is shoreline habitat on the eastern and western terminus of the project area, as well as a manmade causeway between structures 058-3032 and 058-3033. The western limit of the project area is upland mixed residential and industrial use. On the eastern end there are small gravel parking lots for fishermen on both sides of Rea's Bridge Road. Shoreline habitat is riprap on the eastern shore and causeway and poured concrete on the western edge." The photographs in this report noted that the western shoreline is poured concrete and there are no loose bank stabilization materials to search under. This would be considered not suitable or minimal low- quality habitat.

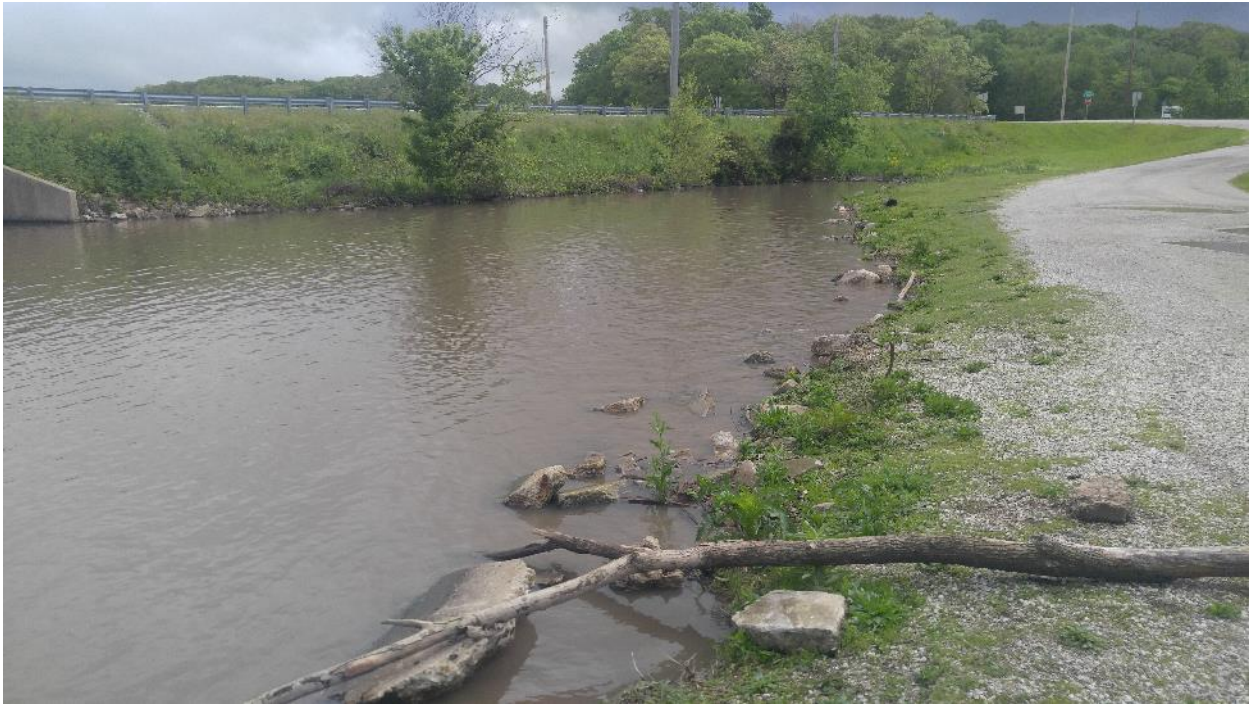
Plate 2. Photograph from the east side of the lake looking north towards the causeway leading Rea's Bridge Road (CH 24) over Lake Decatur. The shore is sparsely vegetated with large concrete chunks and pavers placed for bank stabilization. Photographs taken 20 May 2020 by Andrew R. Kuhns.
