Conservation Plan for the Eastern Sand Darter (*Ammocrypta pellucida*) and the Bigeye Chub (*Hybopsis amblops*) at the Pond 6 Bridge over Middle Fork Vermilion River, Kickapoo State Park, Vermilion County, Illinois

PROJECT NAME: *Pond 6 Bridge Removal, OR 15 (Skyline Drive) over Middle Fork Vermilion River, Structure No. 092-9904. IDNR Project 3-20-033.*

AREA OF IMPACT (acreage): *0.77 acres (Middle Fork of Vermilion River)-Approx. 70 feet wide by 465 feet long. The in-stream footprint is 25 feet upstream and downstream of the existing bridge structure.*

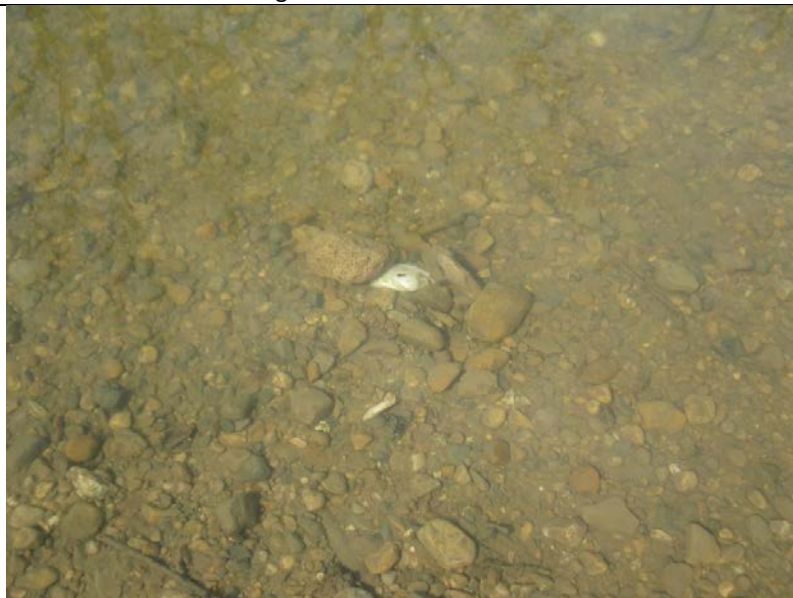
7. Gravel substrate on northeast side of bridge.

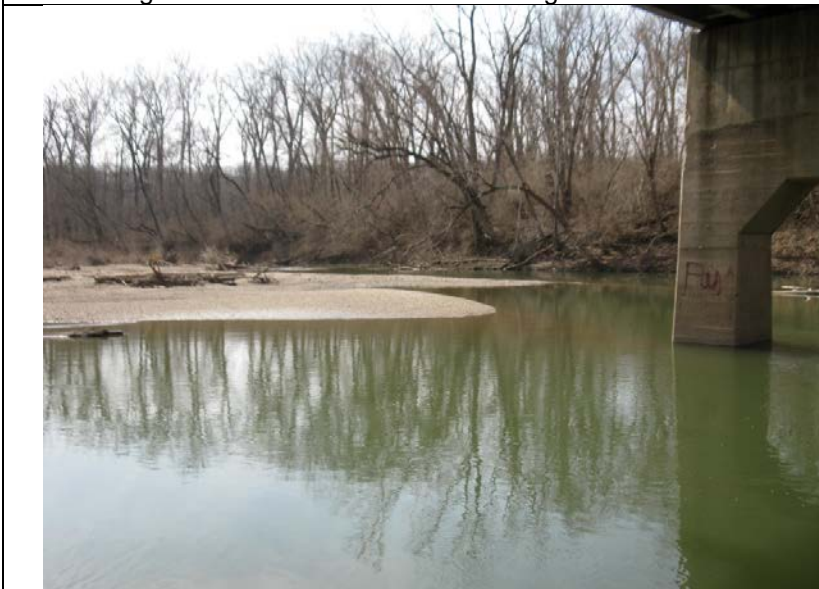
11. Facing southwest under bridge. Sandbar on south side of Pond 6 bridge, Middle Fork Vermilion River.

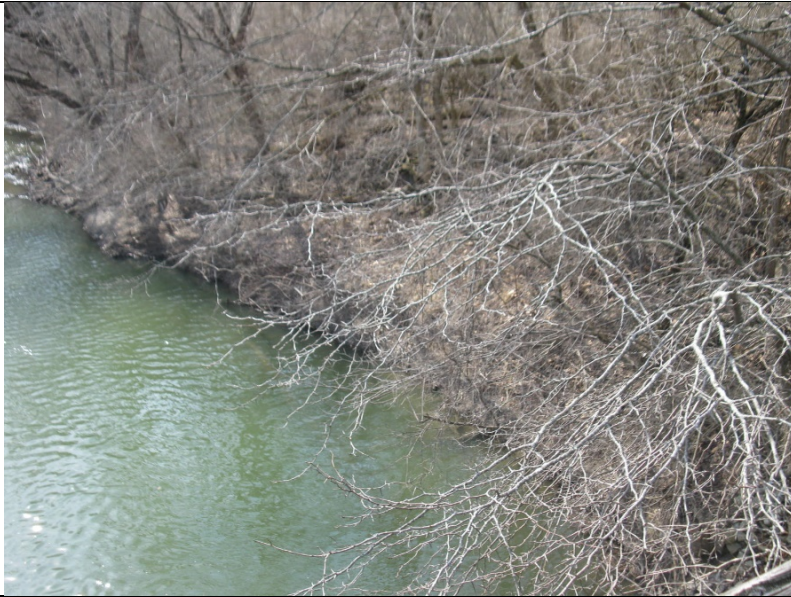
17. River bank on southwest side of bridge.

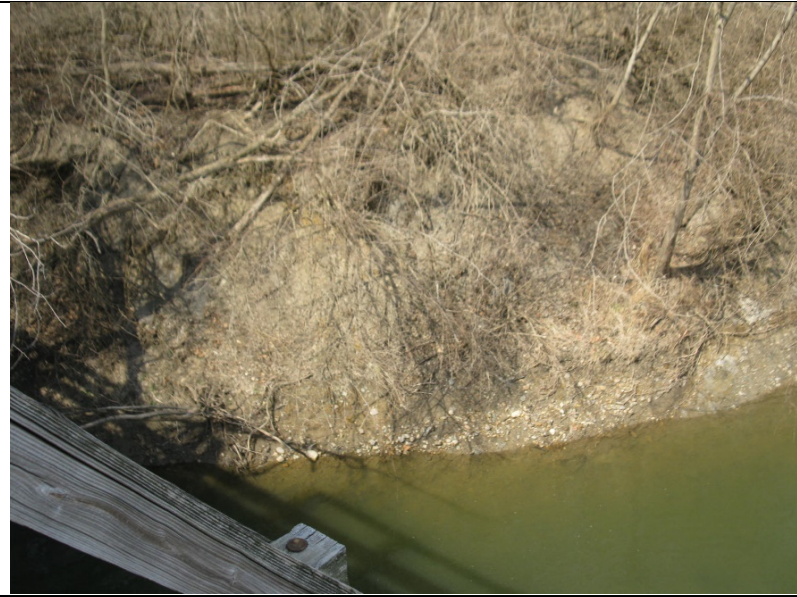
18. River bank on northwest side of bridge.

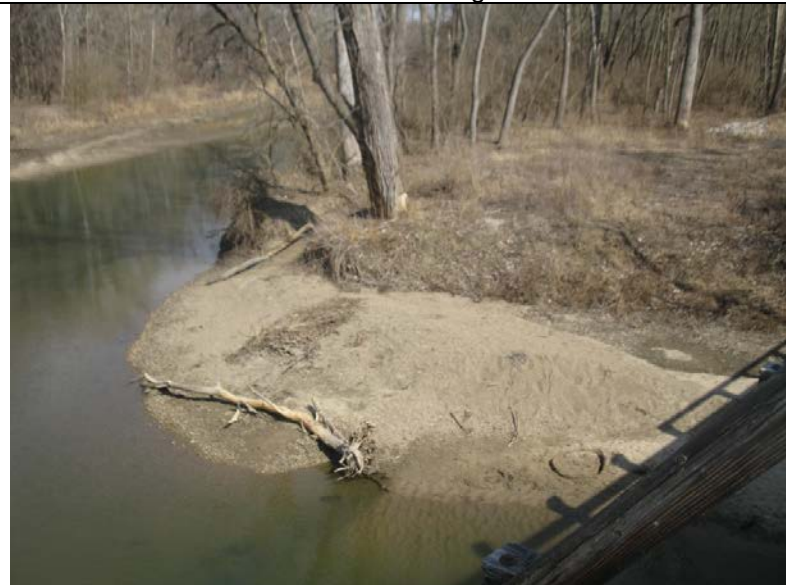
19. River bank on northeast side of bridge.

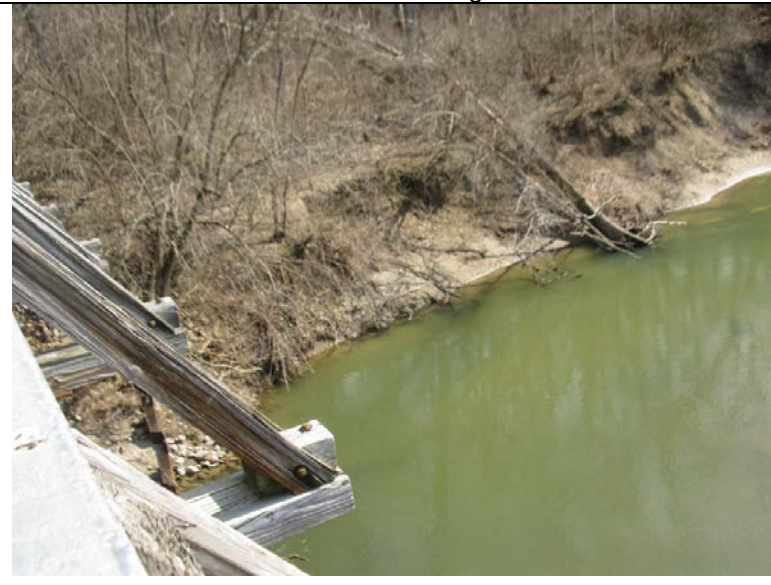
20. River bank on southeast side of bridge.

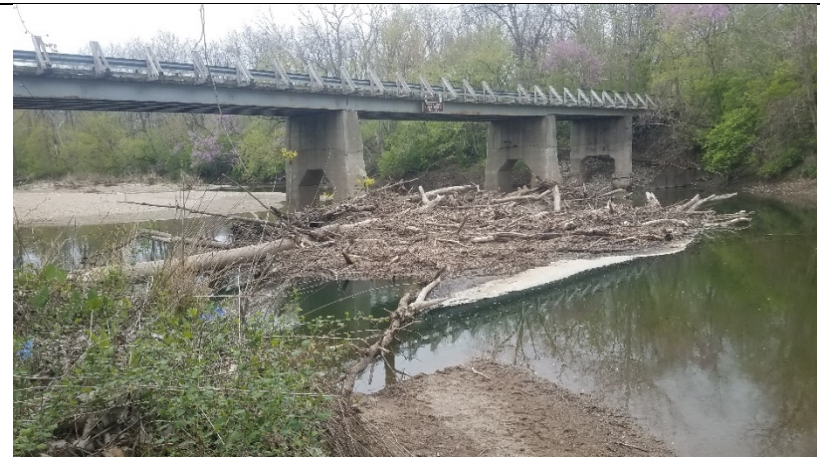
22. View of log jam from northeast side of bridge in April of 2021.

The contractor will need to remove any logs that build up against the piers before any attempt is made to remove the bridge superstructure or piers to avoid any damage to equipment or personnel. The construction limits are 30 feet upstream downstream of the bridge to allow the contractor to work on both sides of the bridge if it starts to lean one direction or the other. This allows them to safely work from the opposite side. The contractor would also have the option of using excavators with longer booms that can reach further to allow the operators of the excavators to reach the structure from a safer distance.

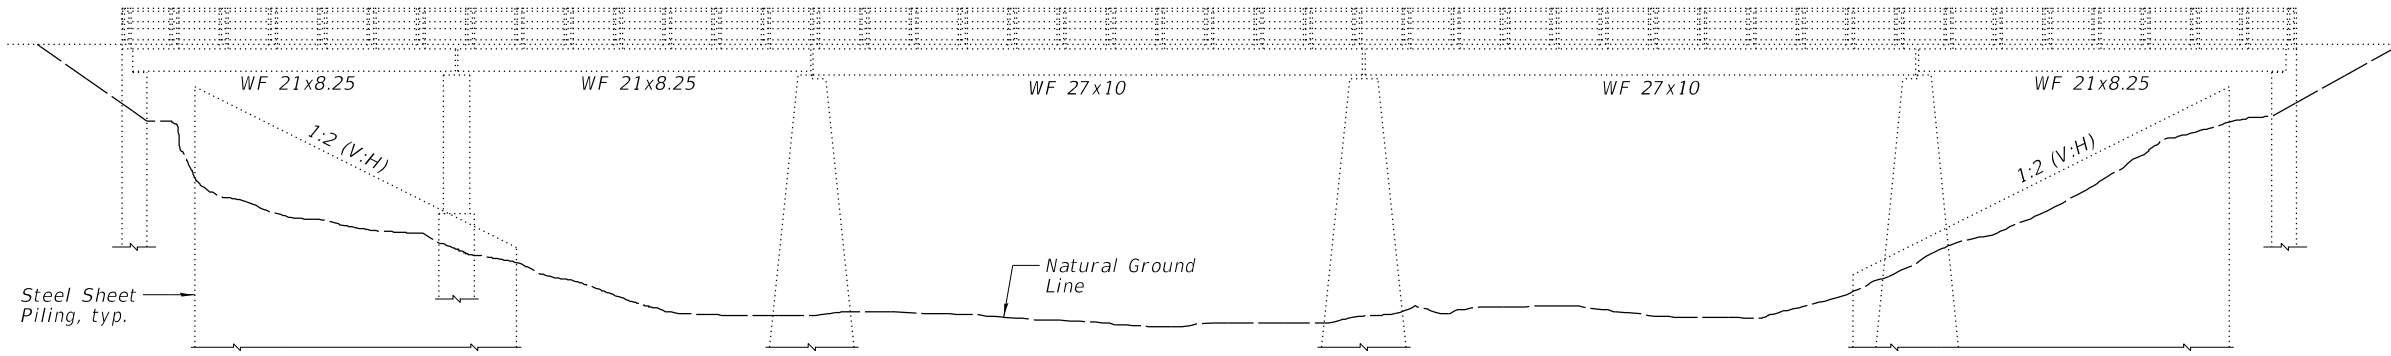
ELEVATION

Existing Structure: Structure No. 092-9904 was built in 1900, there is no Section Number. In 1987 two sheet pile walls were installed at each end span with riprap to stabilize and restore the embankments. The superstructure consists of a five-span simple rolled steel beam bridge with a 6" thick timber deck. The substructure consists of concrete abutments and four piers. However, foundation details at the substructure units are not known. The back-to-back of abutments length measures 241'-8" and the out-to-out deck width measures 18'-0". The span lengths measure 36'-0", 39'-6", 61'-4", 61'-6", and 41'-0". The structure is not skewed.

- 1.) Remove the existing bridge including substructure units and sheet pile walls to a minimum of 1'-0" below existing grade.

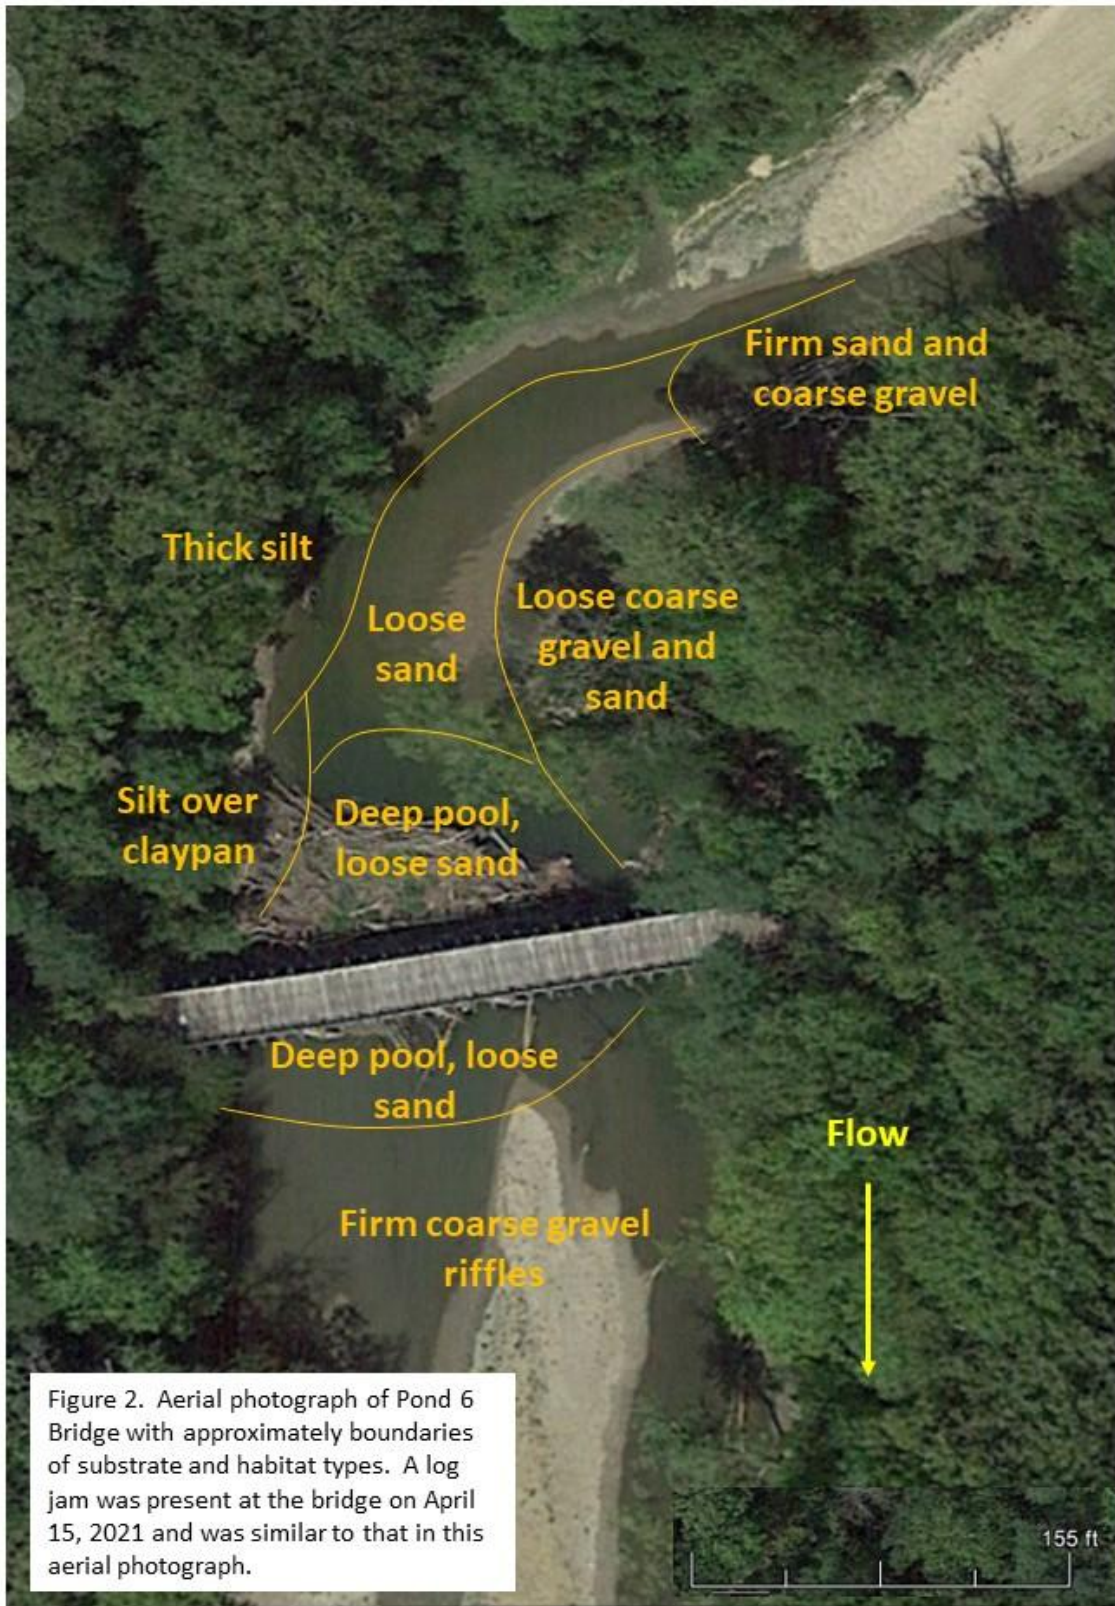
The area near the west bank upstream of the bridge was heavily sedimented with silt to 0.5 meters deep in some areas (Figure 2). Near the east bank upstream of the bridge the substrate was loosely consolidated sand and coarse gravel. The middle of the channel upstream of the bridge was loosely consolidated sand. Approximately 75 meters upstream of the bridge the sand and coarse gravel substrate became firmer. Most of the habitat upstream of the bridge may be characterized as pool and run. Downstream of the bridge pool is an extensive riffle with coarse gravel substrate (Figure 2; Photograph 4). Mean depth was approximately 0.3 meters.

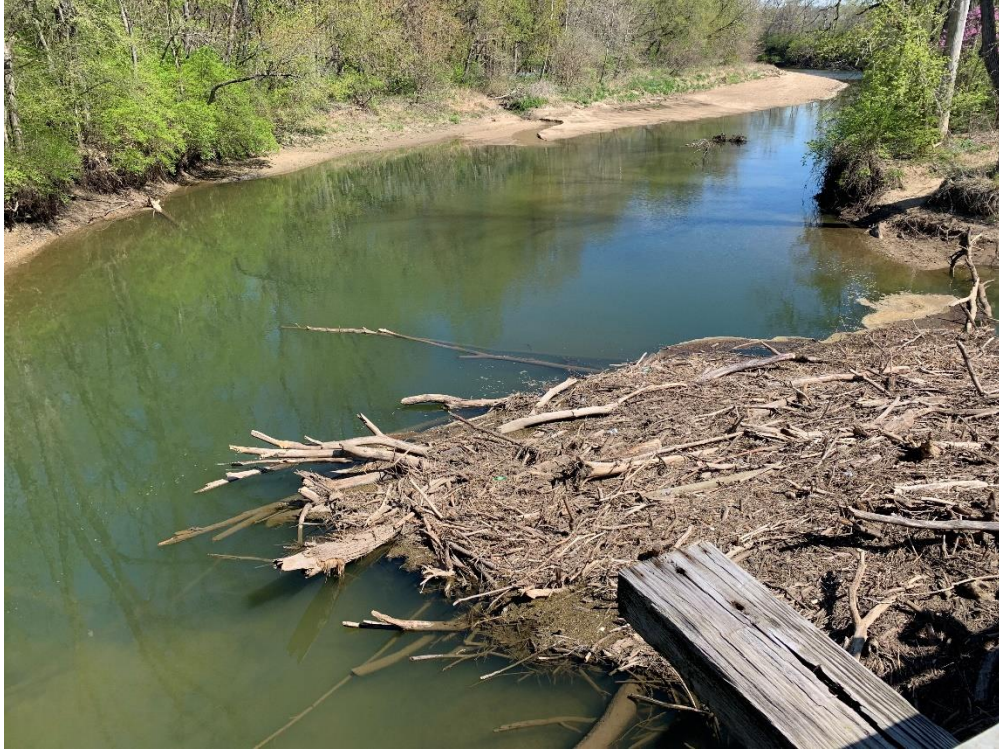
Photograph 1. Middle Fork Vermilion River looking upstream (north) from the Pond 6 Bridge. The logjam is in the foreground.

Deep scour pools and silt deposits near the bridge, and unconsolidated substrates upstream of the bridge, suggest the logjam is producing an actively shifting channel with mobile substrates. The area 50 meters upstream and 20 meters downstream is likely poor quality habitat for mussels. The absence of live mussels in this reach supports this conclusion.

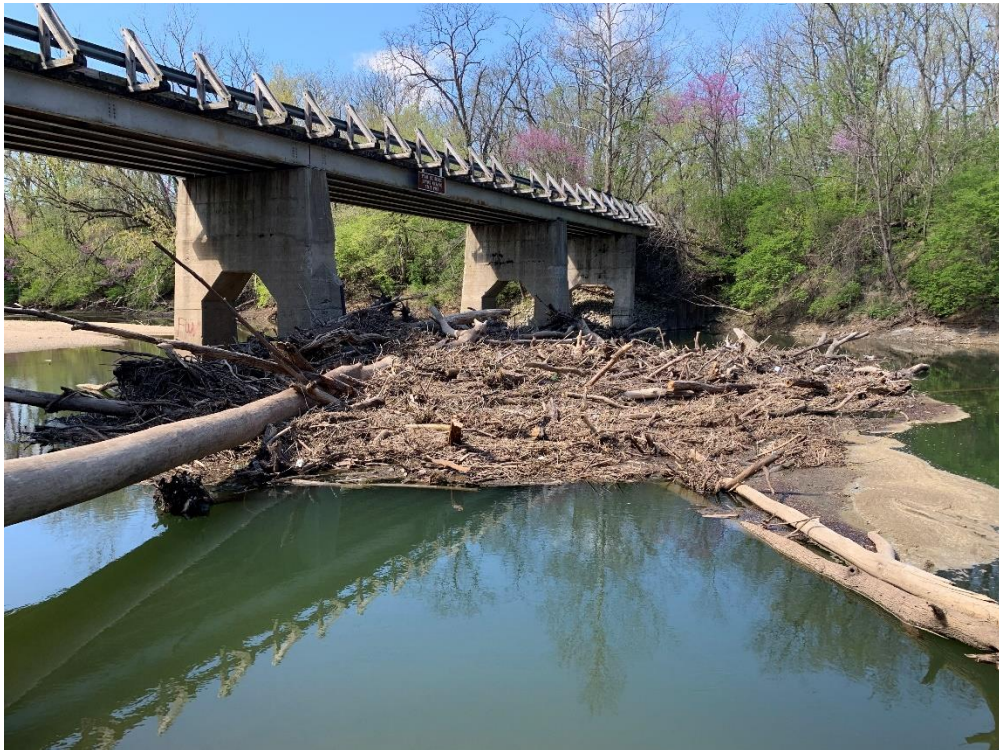
Photograph 2. Facing west towards the Pond 6 Bridge and logjam from the east bank of the Middle Fork Vermilion River.

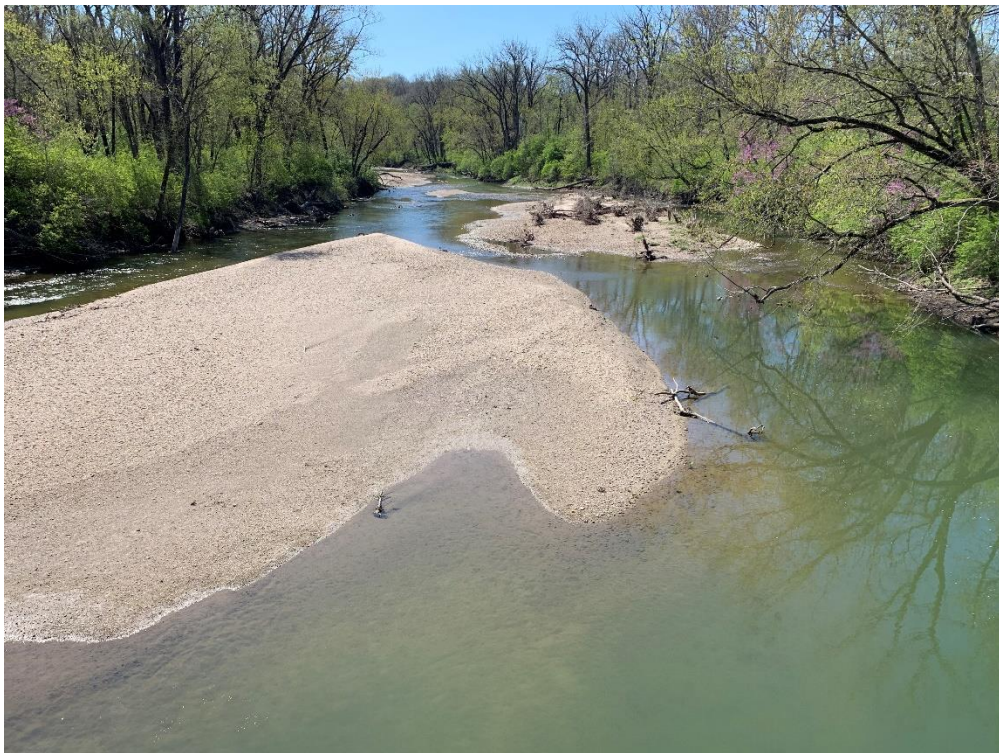
Photograph 4. Middle Fork Vermilion River facing downstream (south) from the Pond 6 Bridge.
