Wolverine Pipe Line Company

Conservation Plan and Incidental Take Permit Application Amendment

Wolverine CU-LK Pipeline Repairs Project

November 22, 2023

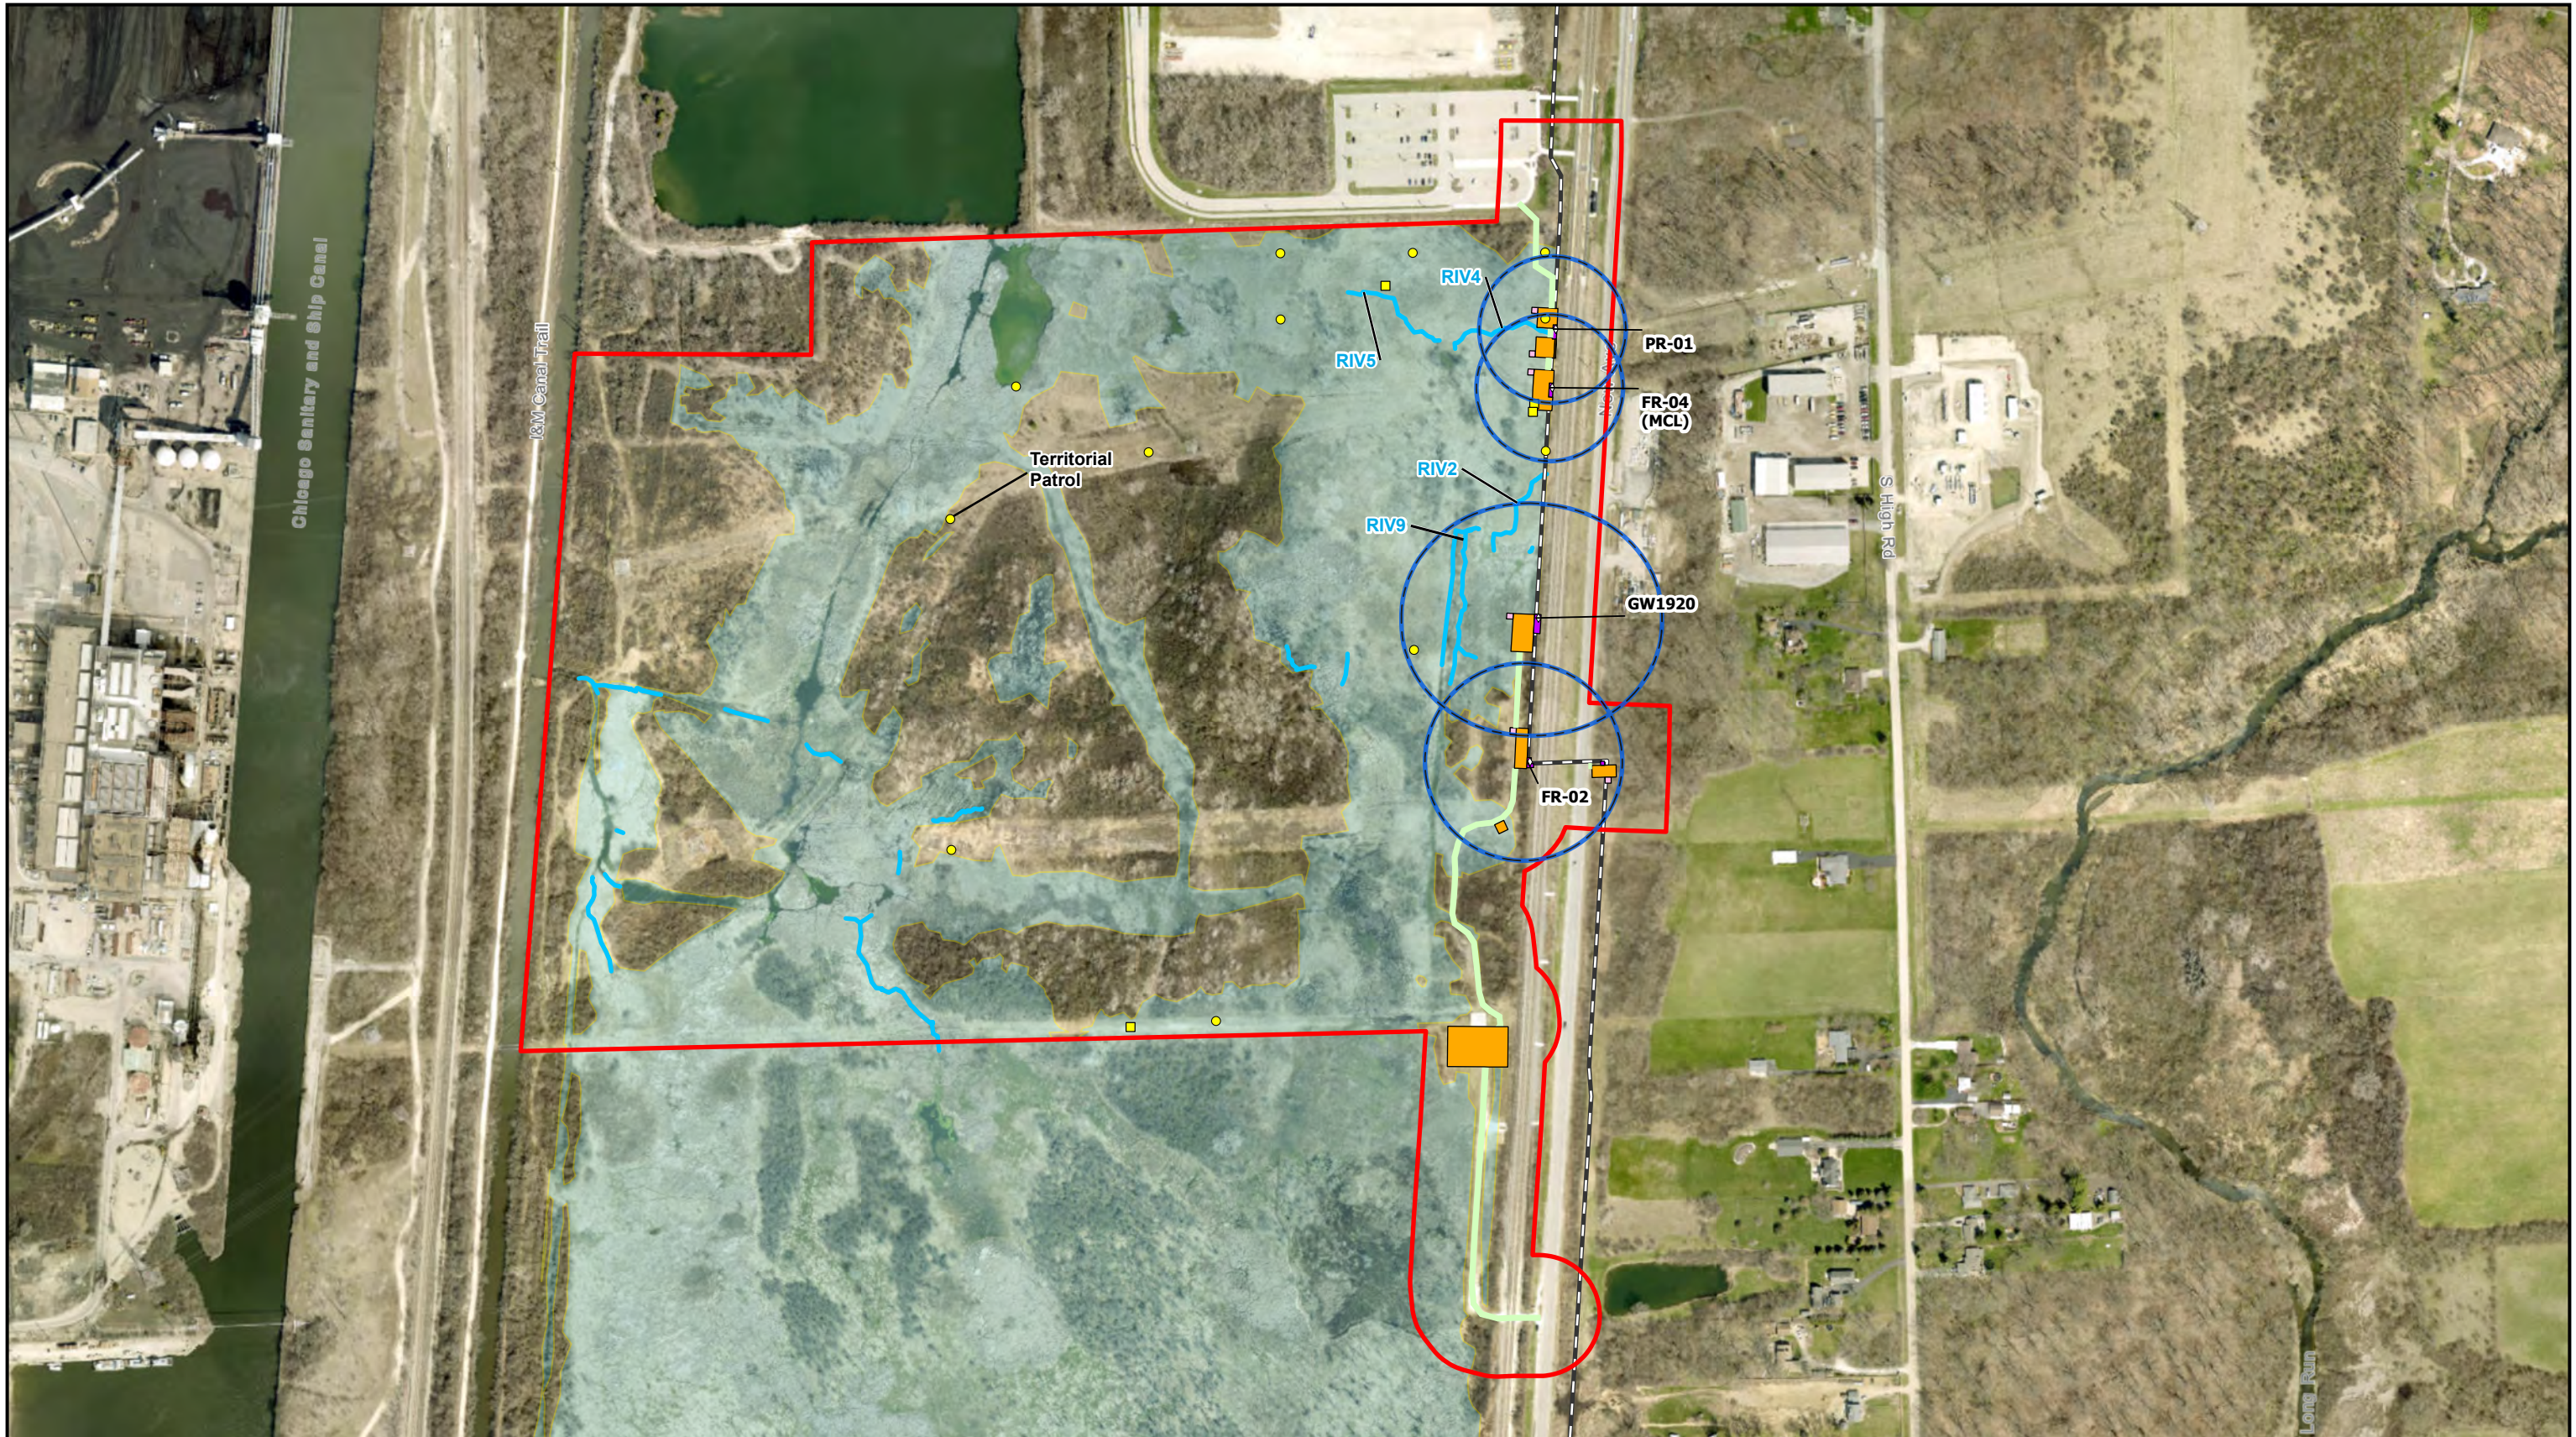
Figure 2
Project Workspace and Effects
 WPL CU-LK Repairs
 Will County, Illinois

2021 HED Adult Point Count and Incidental Observations		Dig Location		Permit Area	
■	Incidental Adult Observation	◇	Dig Location		Permit Area
●	Point Count Adult Observation	—	Rivulet		Dewatering
			Lemont to Lockport 18"		Excavation
			Delineated Wetlands		Temporary Workspace
					Access Road
					Projected Conservative Radius of Influence

The Project involves the temporary excavation, inspection, and repair of one newly identified anomaly or pipeline integrity issue, herein referred to as anomalies. WPL assigns unique identifiers to each anomaly. From north to south the anomalies included in this Project are PR-01, FR-04, GW 1920, and FR-02 (Appendix A – Figure 2). Repairs may require excavation of up to 162 feet of pipeline (35 feet for PR-01, 35 feet for FR-04, 50 feet for GW 1920, and 42 feet for FR-02), 152 feet of which would be within HED critical habitat. New excavations for pipeline repairs would impact approximately 0.02 acre, bringing the total excavation to 0.05 acre in total within critical habitat. In addition to excavation, temporary impacts for access routes to the new location establishing temporary workspace from which equipment would be positioned to excavate these locations, and dewatering discharge areas would involve temporary disturbance of additional land. This brings total temporary impacts to 1.24 acres, of which 0.61 acre are within wetland (Appendix A – Figure 2).

Based on the analysis above, the ROI intersects known crayfish burrows associated with RIV2 and RIV9. The area in proximity to the proposed excavation was searched very thoroughly for burrows after the spring prescribed burn in 2021, when there was very little vegetative cover, and again in summer 2023. Eight burrows were within the original ROI; with the addition of a new and larger ROI associated with GW 1920, 21 additional burrows or a total of 29 burrows are within the potential drawdown area. If any crayfish excavate new burrows within the ROI prior to the start of work, then those burrows may be influenced by pumping, although summer 2023 surveys suggest that the number and location of burrows has changed little. HED larvae would be potentially affected only if present within the ROI.

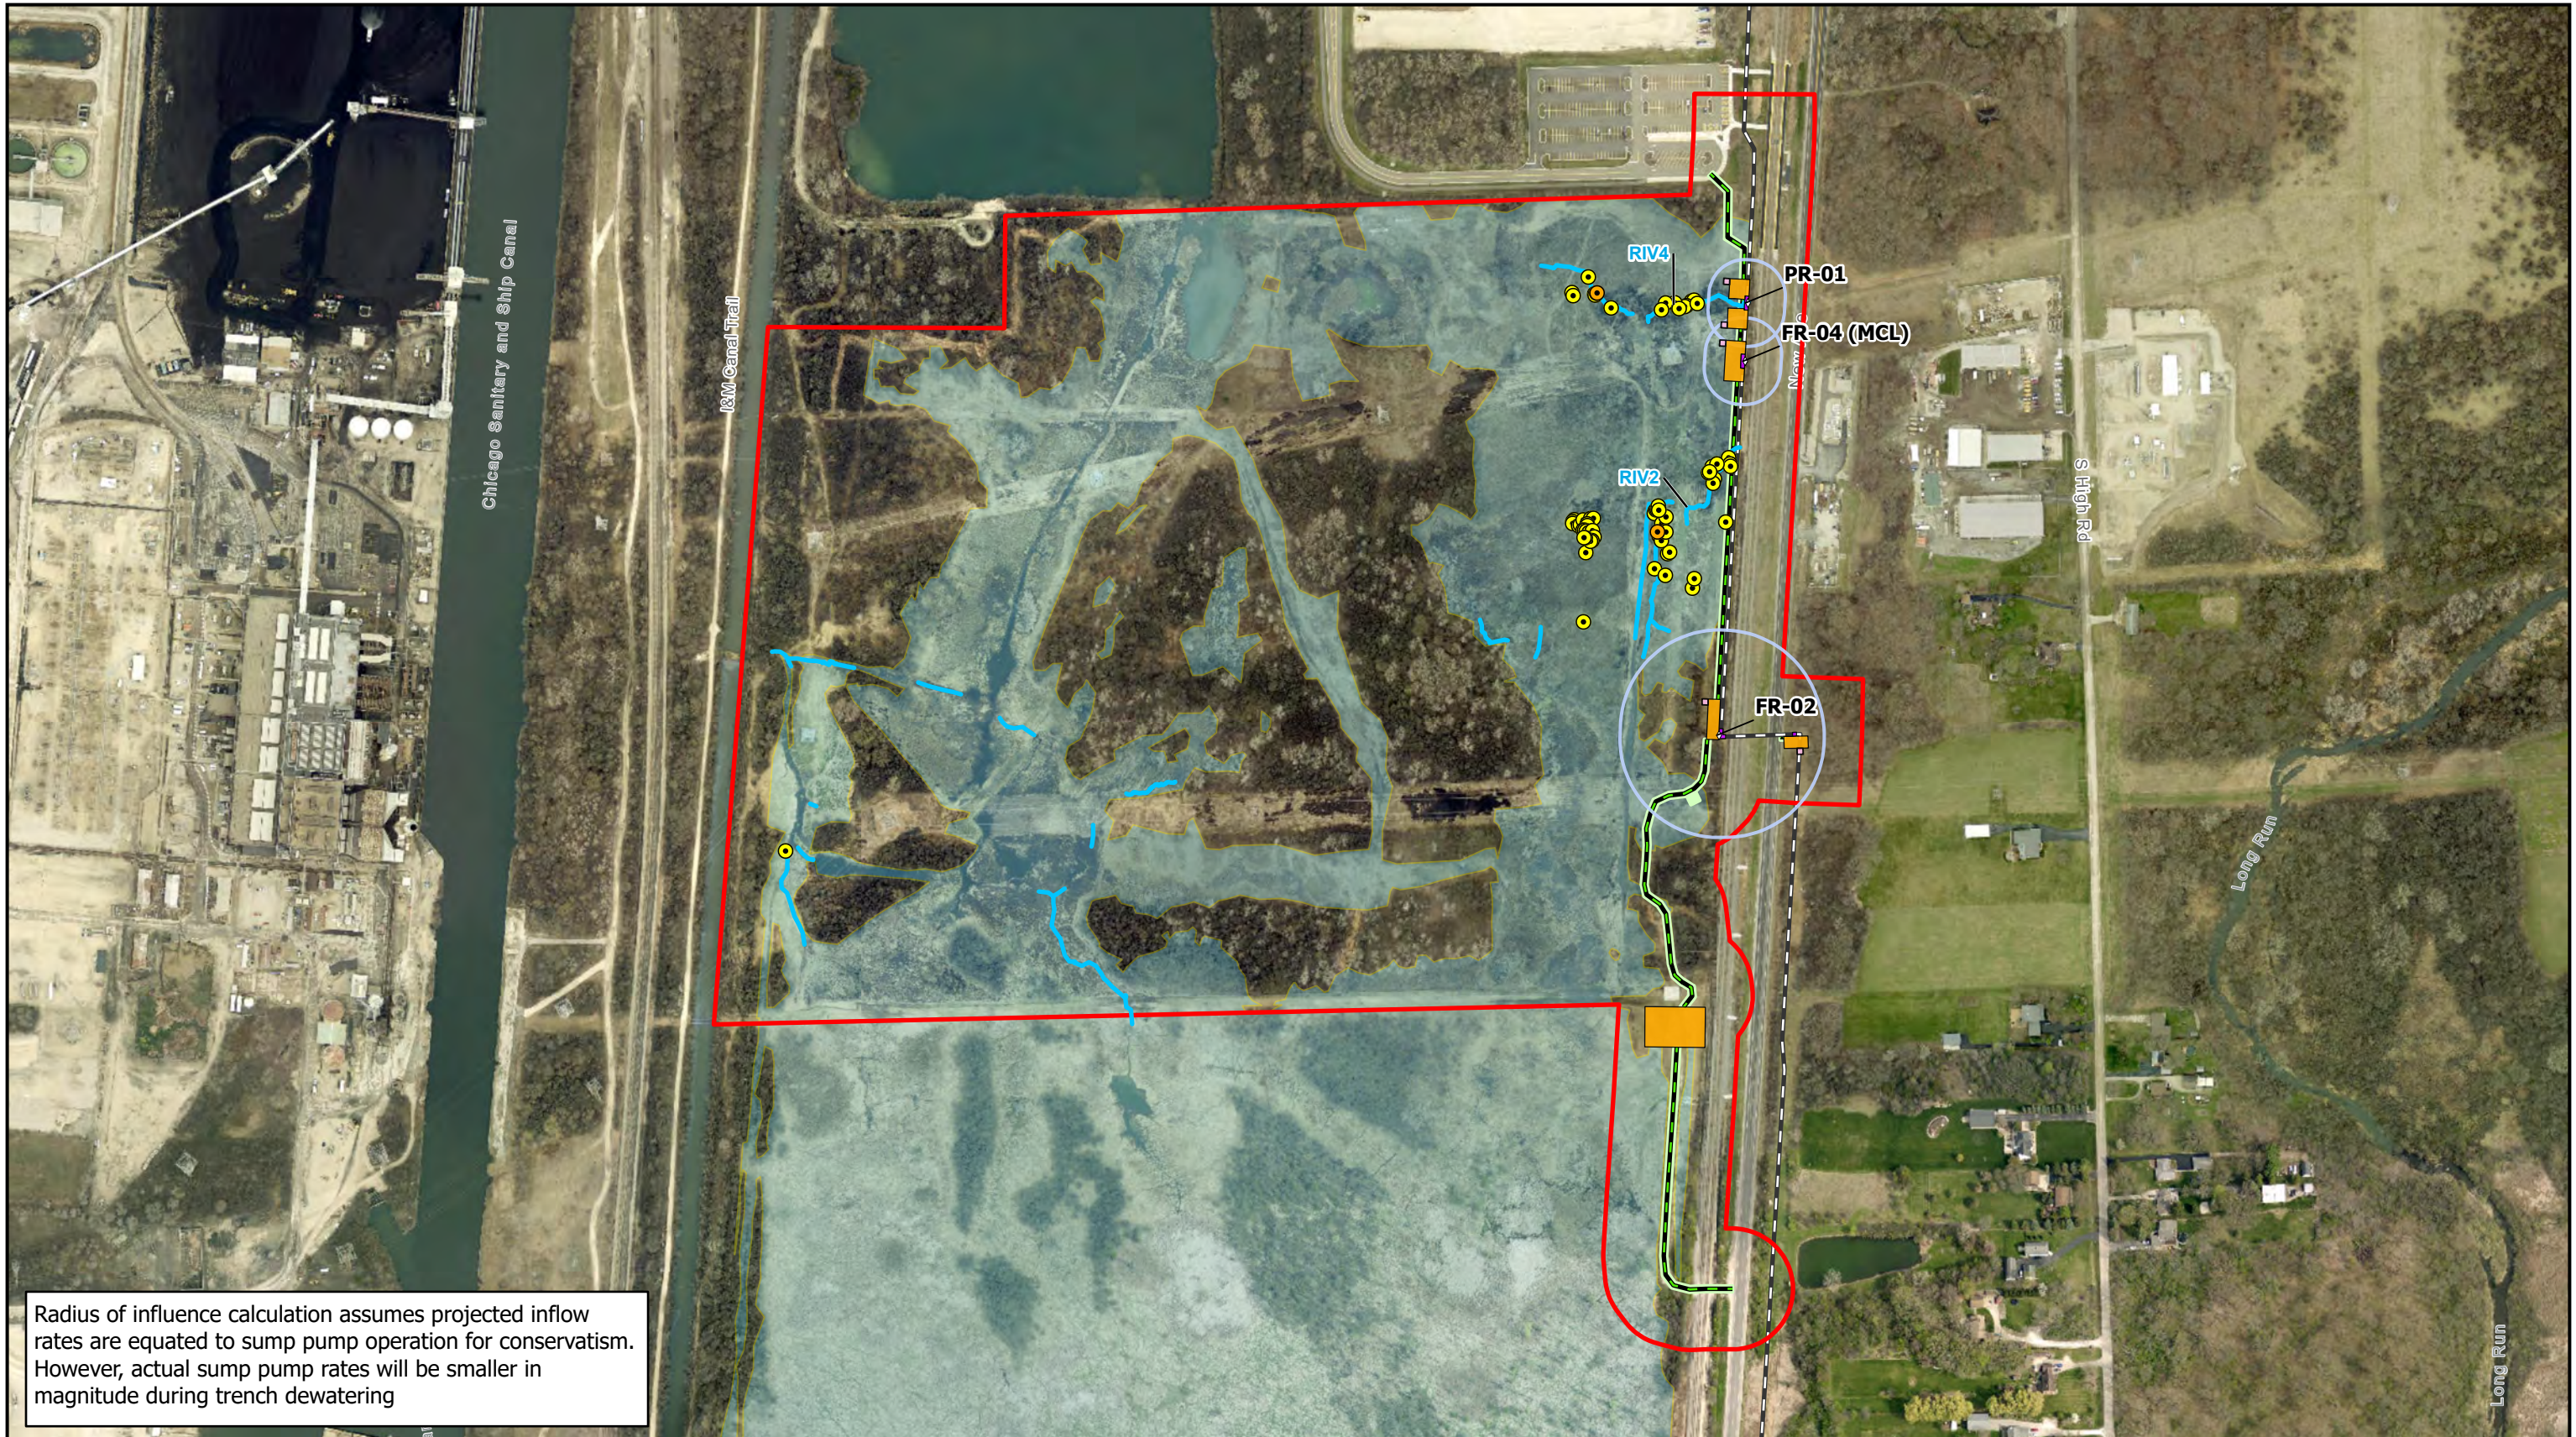
Radius of influence calculation assumes projected inflow rates are equated to sump pump operation for conservatism. However, actual sump pump rates will be smaller in magnitude during trench dewatering

The maximum depth of excavation during pipeline repairs at GW 1920 is not expected to exceed six to eight feet. A trench excavation dewatering analysis was performed for the new location to predict how much groundwater may flow into the excavation and the potential Radius of Influence (ROI) that would propagate while operating a water pump (described in Section 2.2.5.3) to remove water from the open excavation. The analysis used the following assumptions:

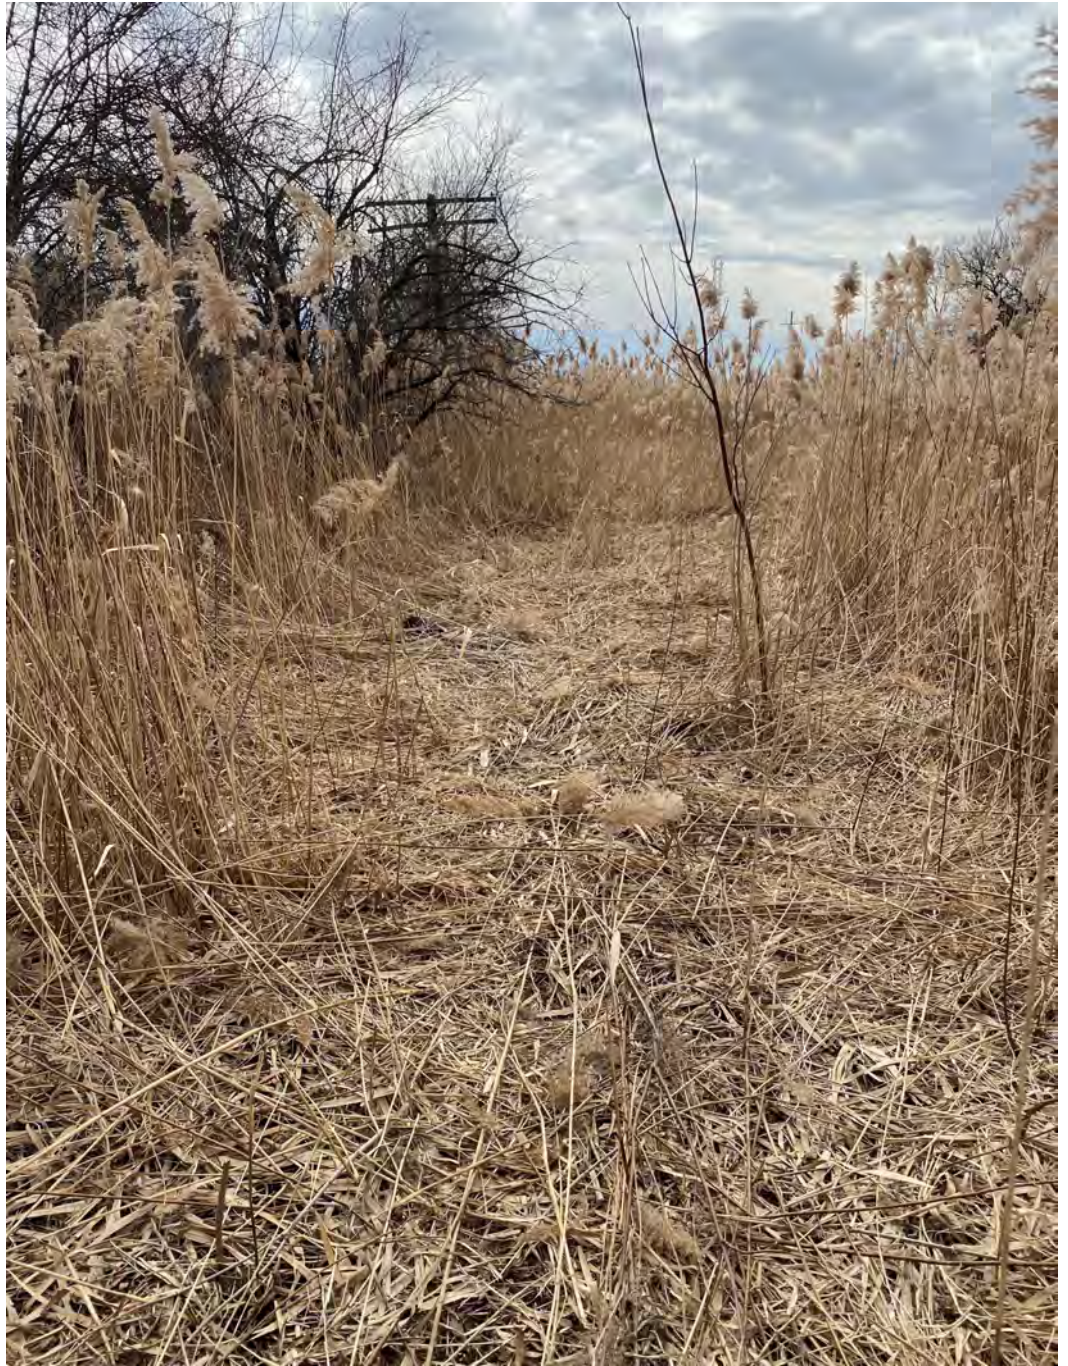
Location FR-04.
Standing at northern
excavation extent
facing south.

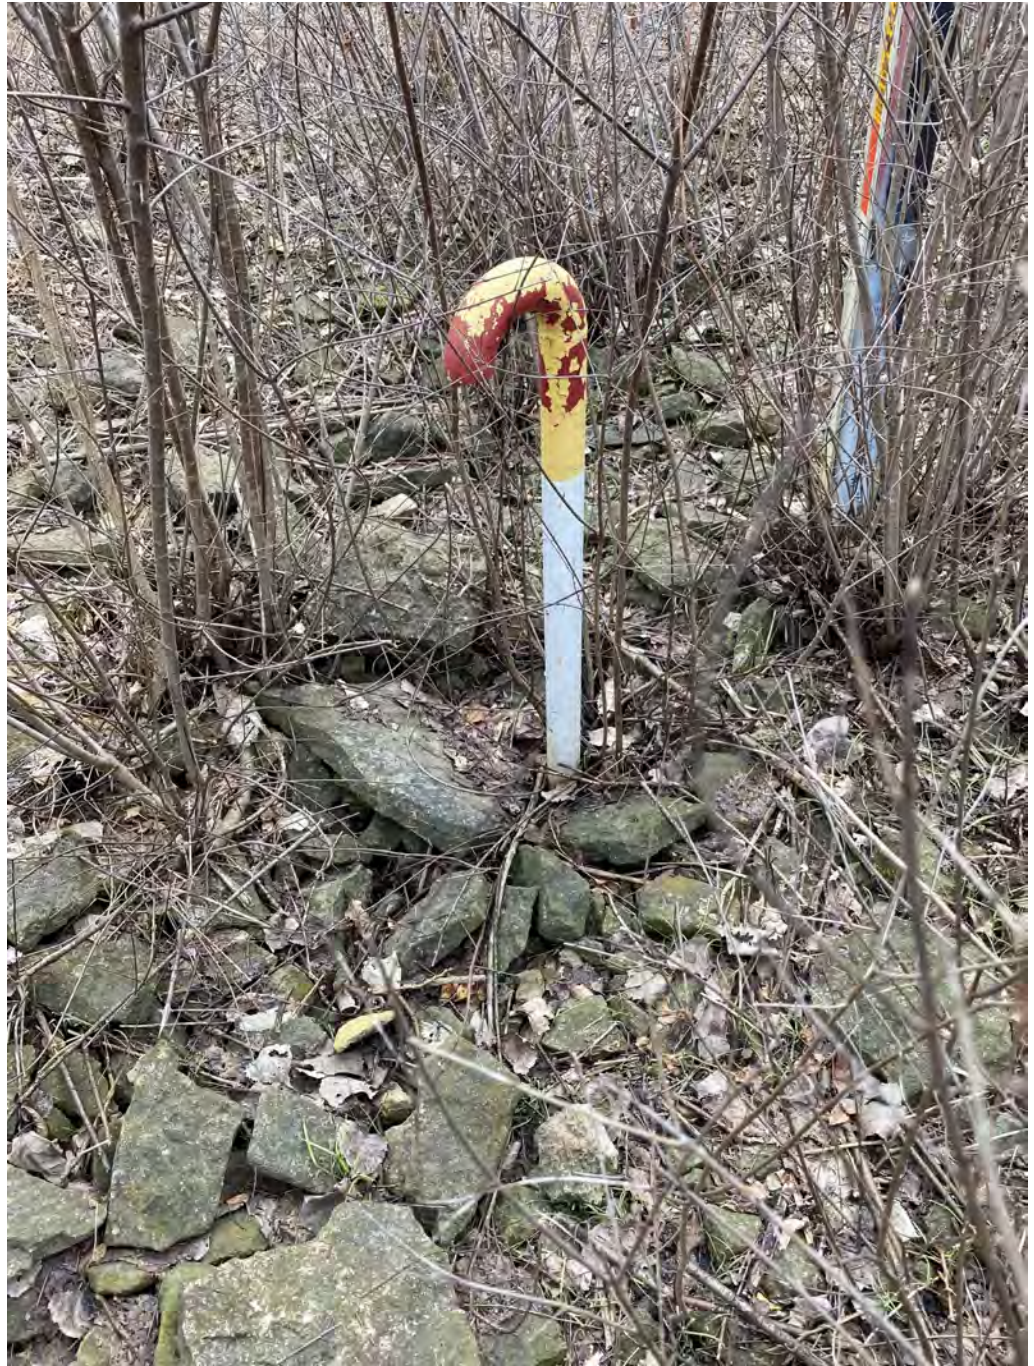
Location FR-02 west of New Avenue. Large rocks covering ground surface near existing casing vent.

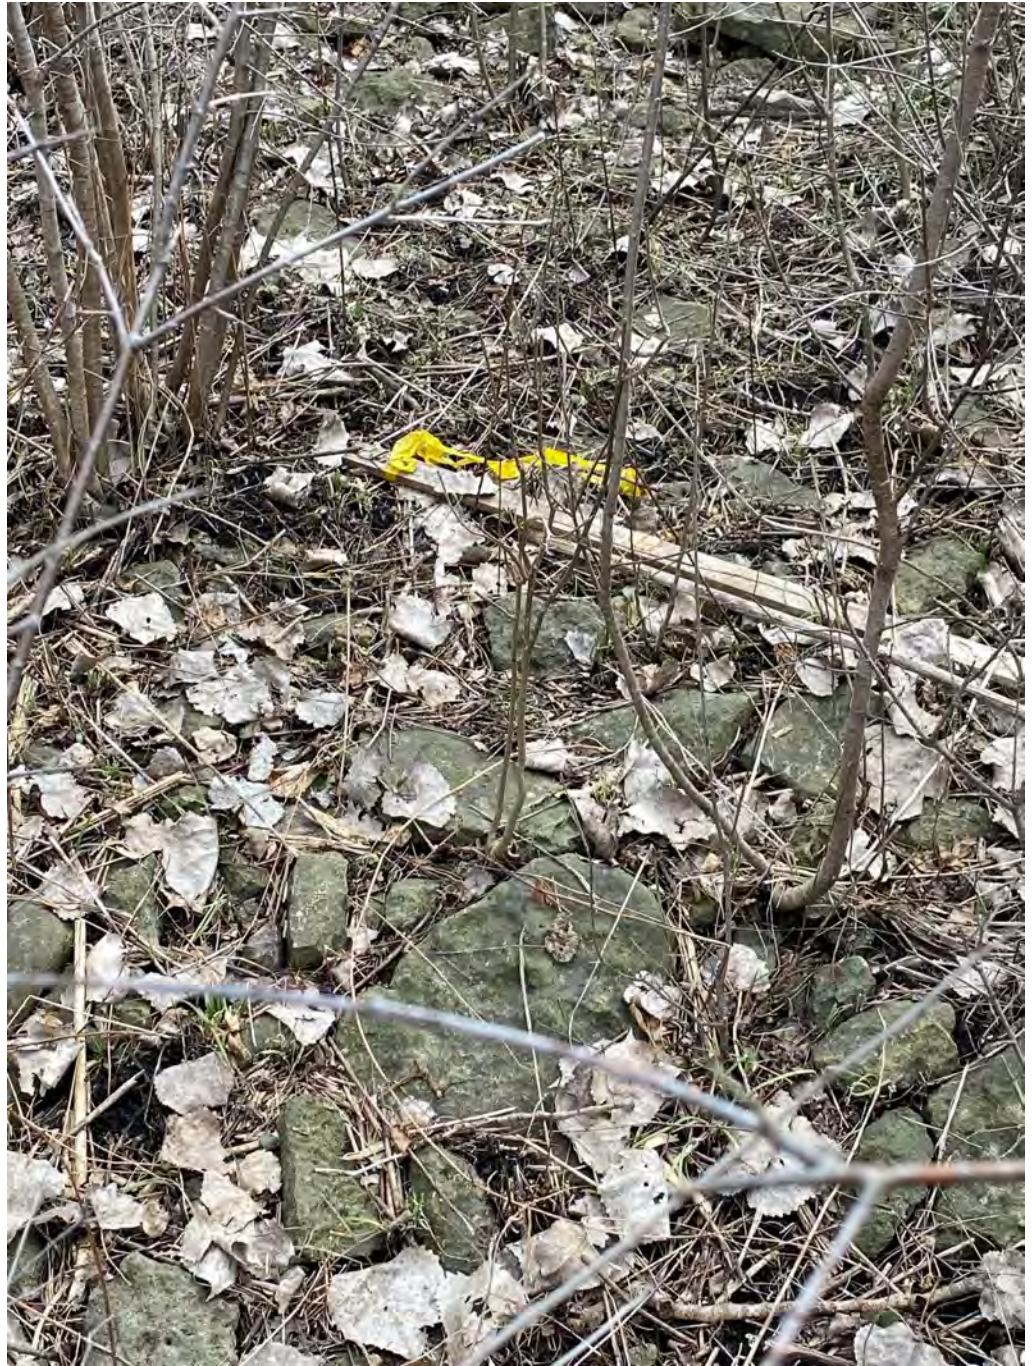
Location FR-02 west of New Avenue. Large rocks covering ground surface.

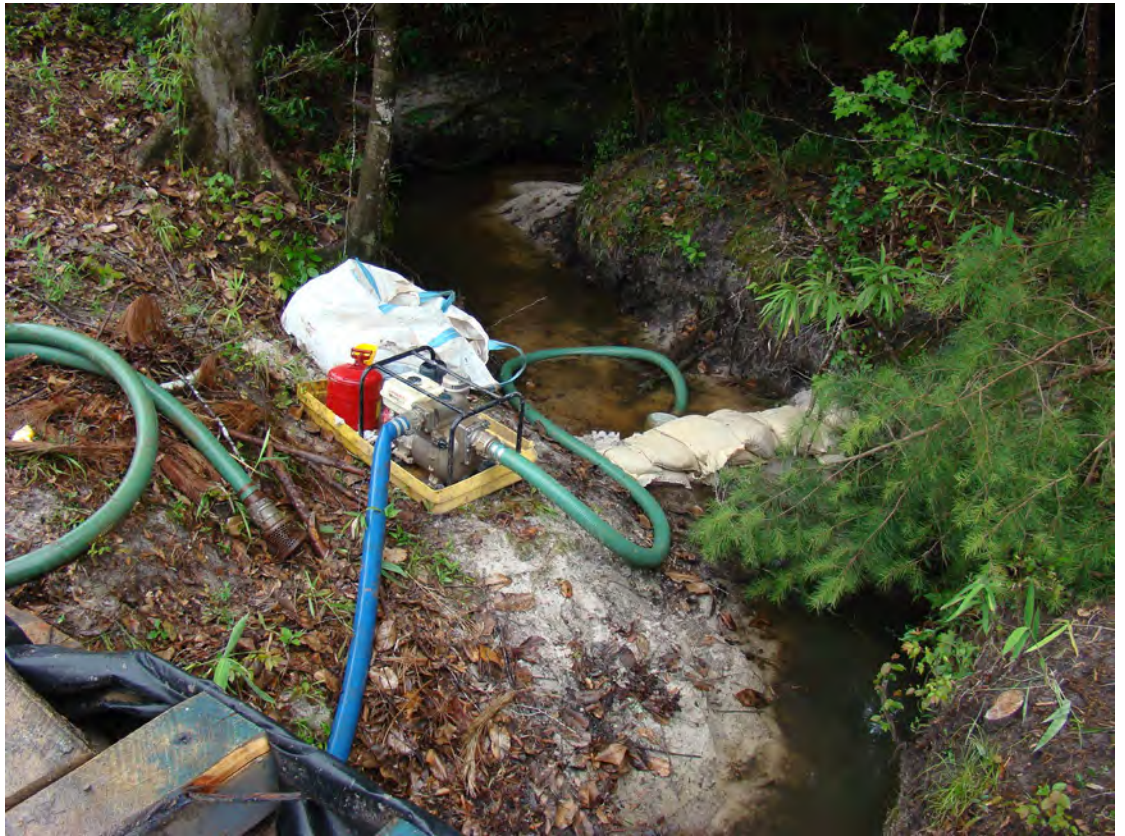
Sandbag cofferdam, screened intake, and pump on a small stream. Pump placed in secondary containment.

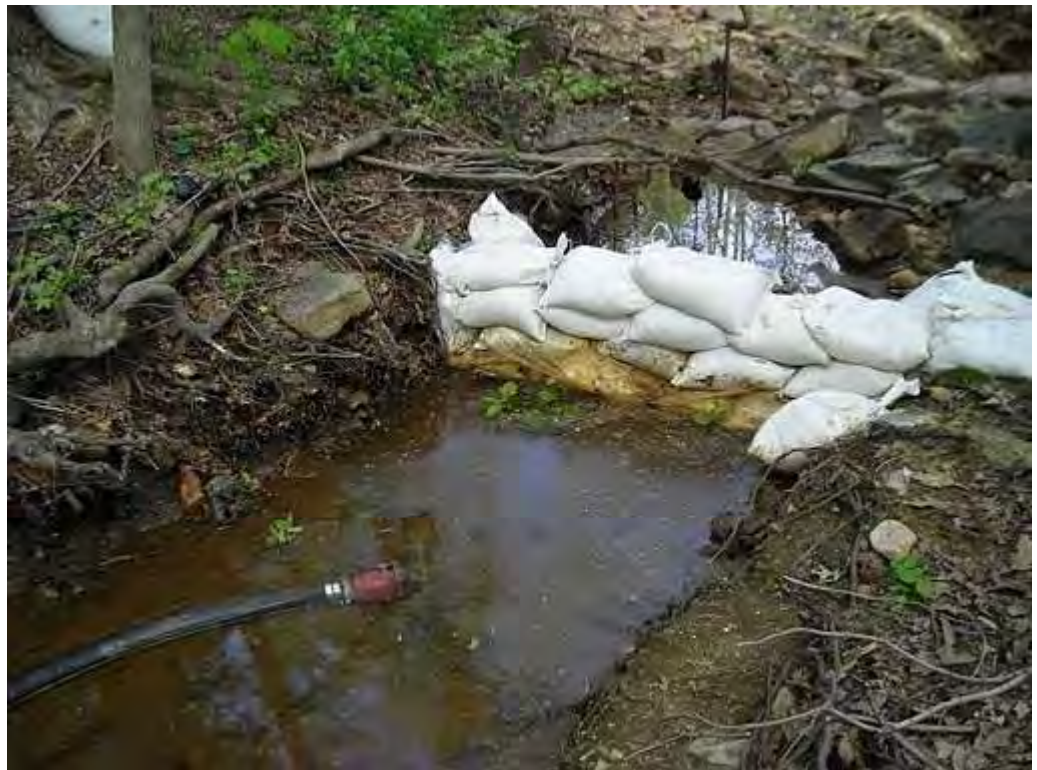
Sandbag cofferdam and screened intake on a small stream.

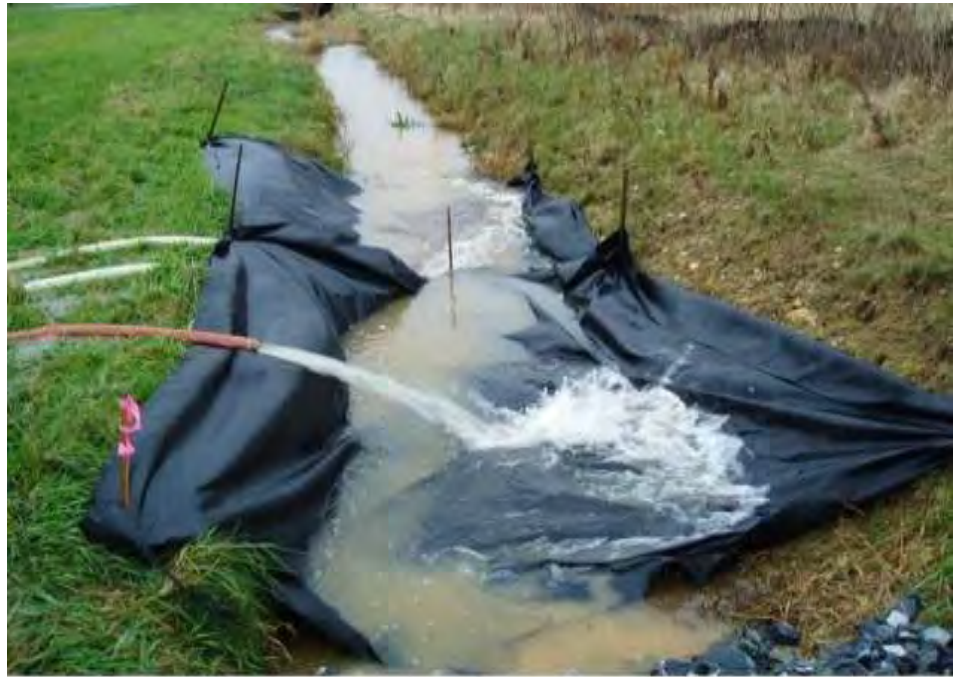
Stream bypass discharge to non-erodible surface (geotextile).

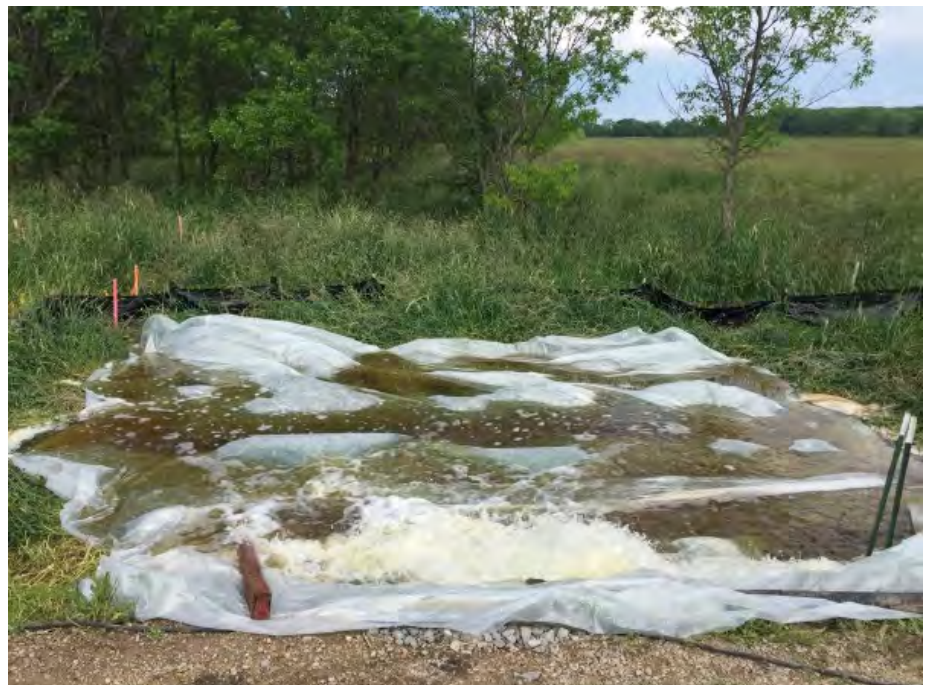
Stream bypass discharge to non-erodible surface (plastic sheeting).

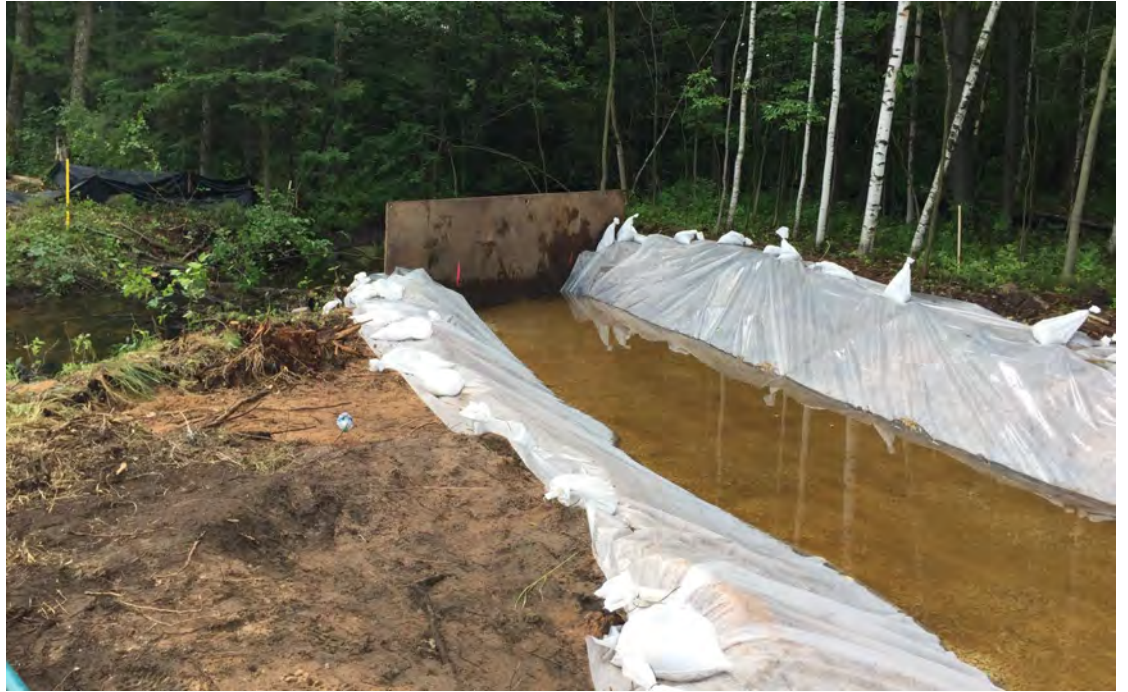
Steel/wood sheet
temporary dam

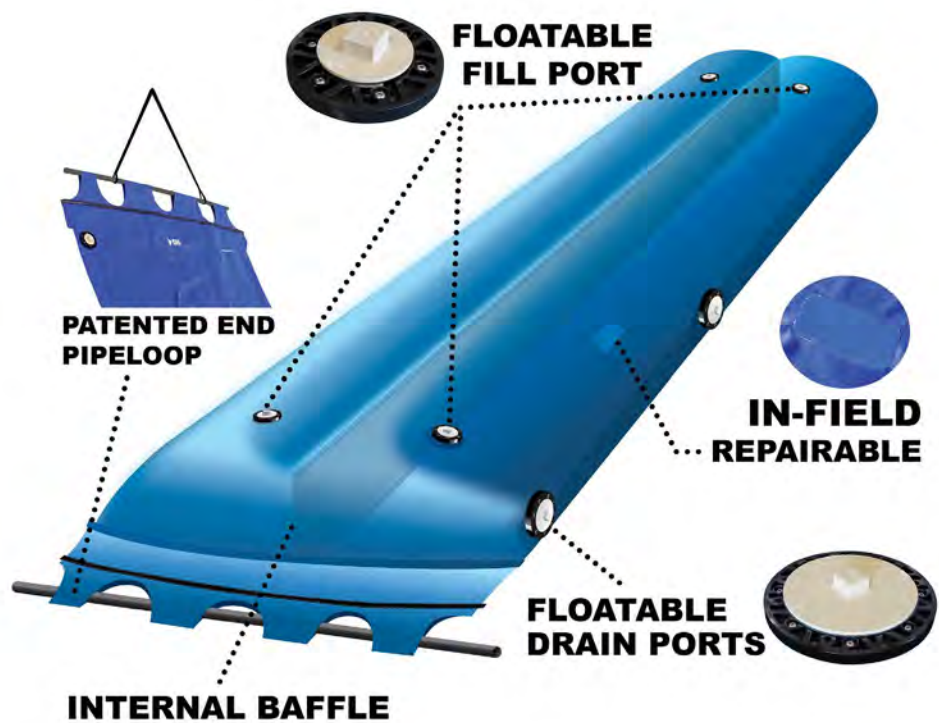
Temporary aqua-dam

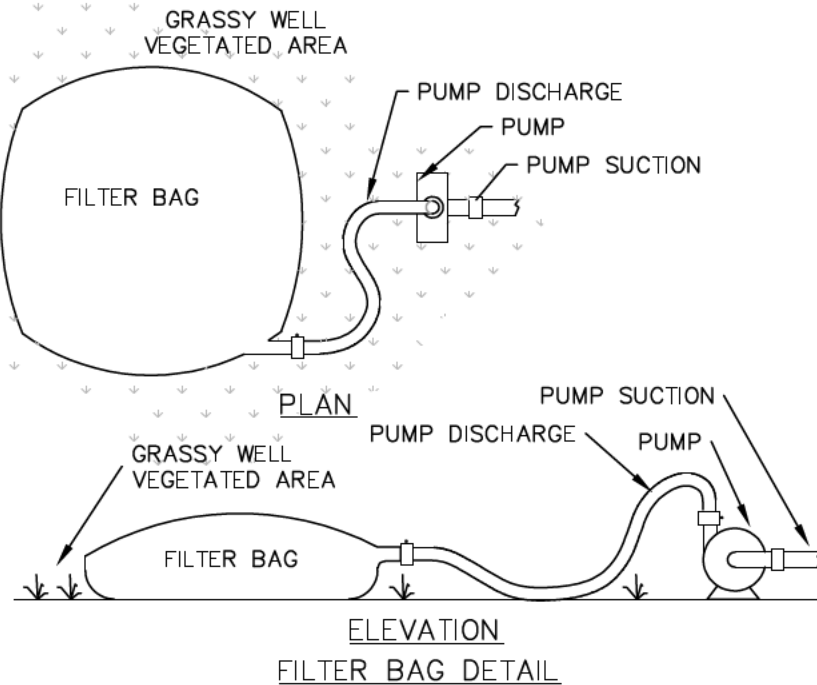
FILTER BAG DETAIL

6. FILTER BAGS SHALL BE INSPECTED DAILY. IF ANY PROBLEM IS DETECTED, PUMPING SHALL CEASE IMMEDIATELY AND NOT RESUME UNTIL THE PROBLEM IS CORRECTED

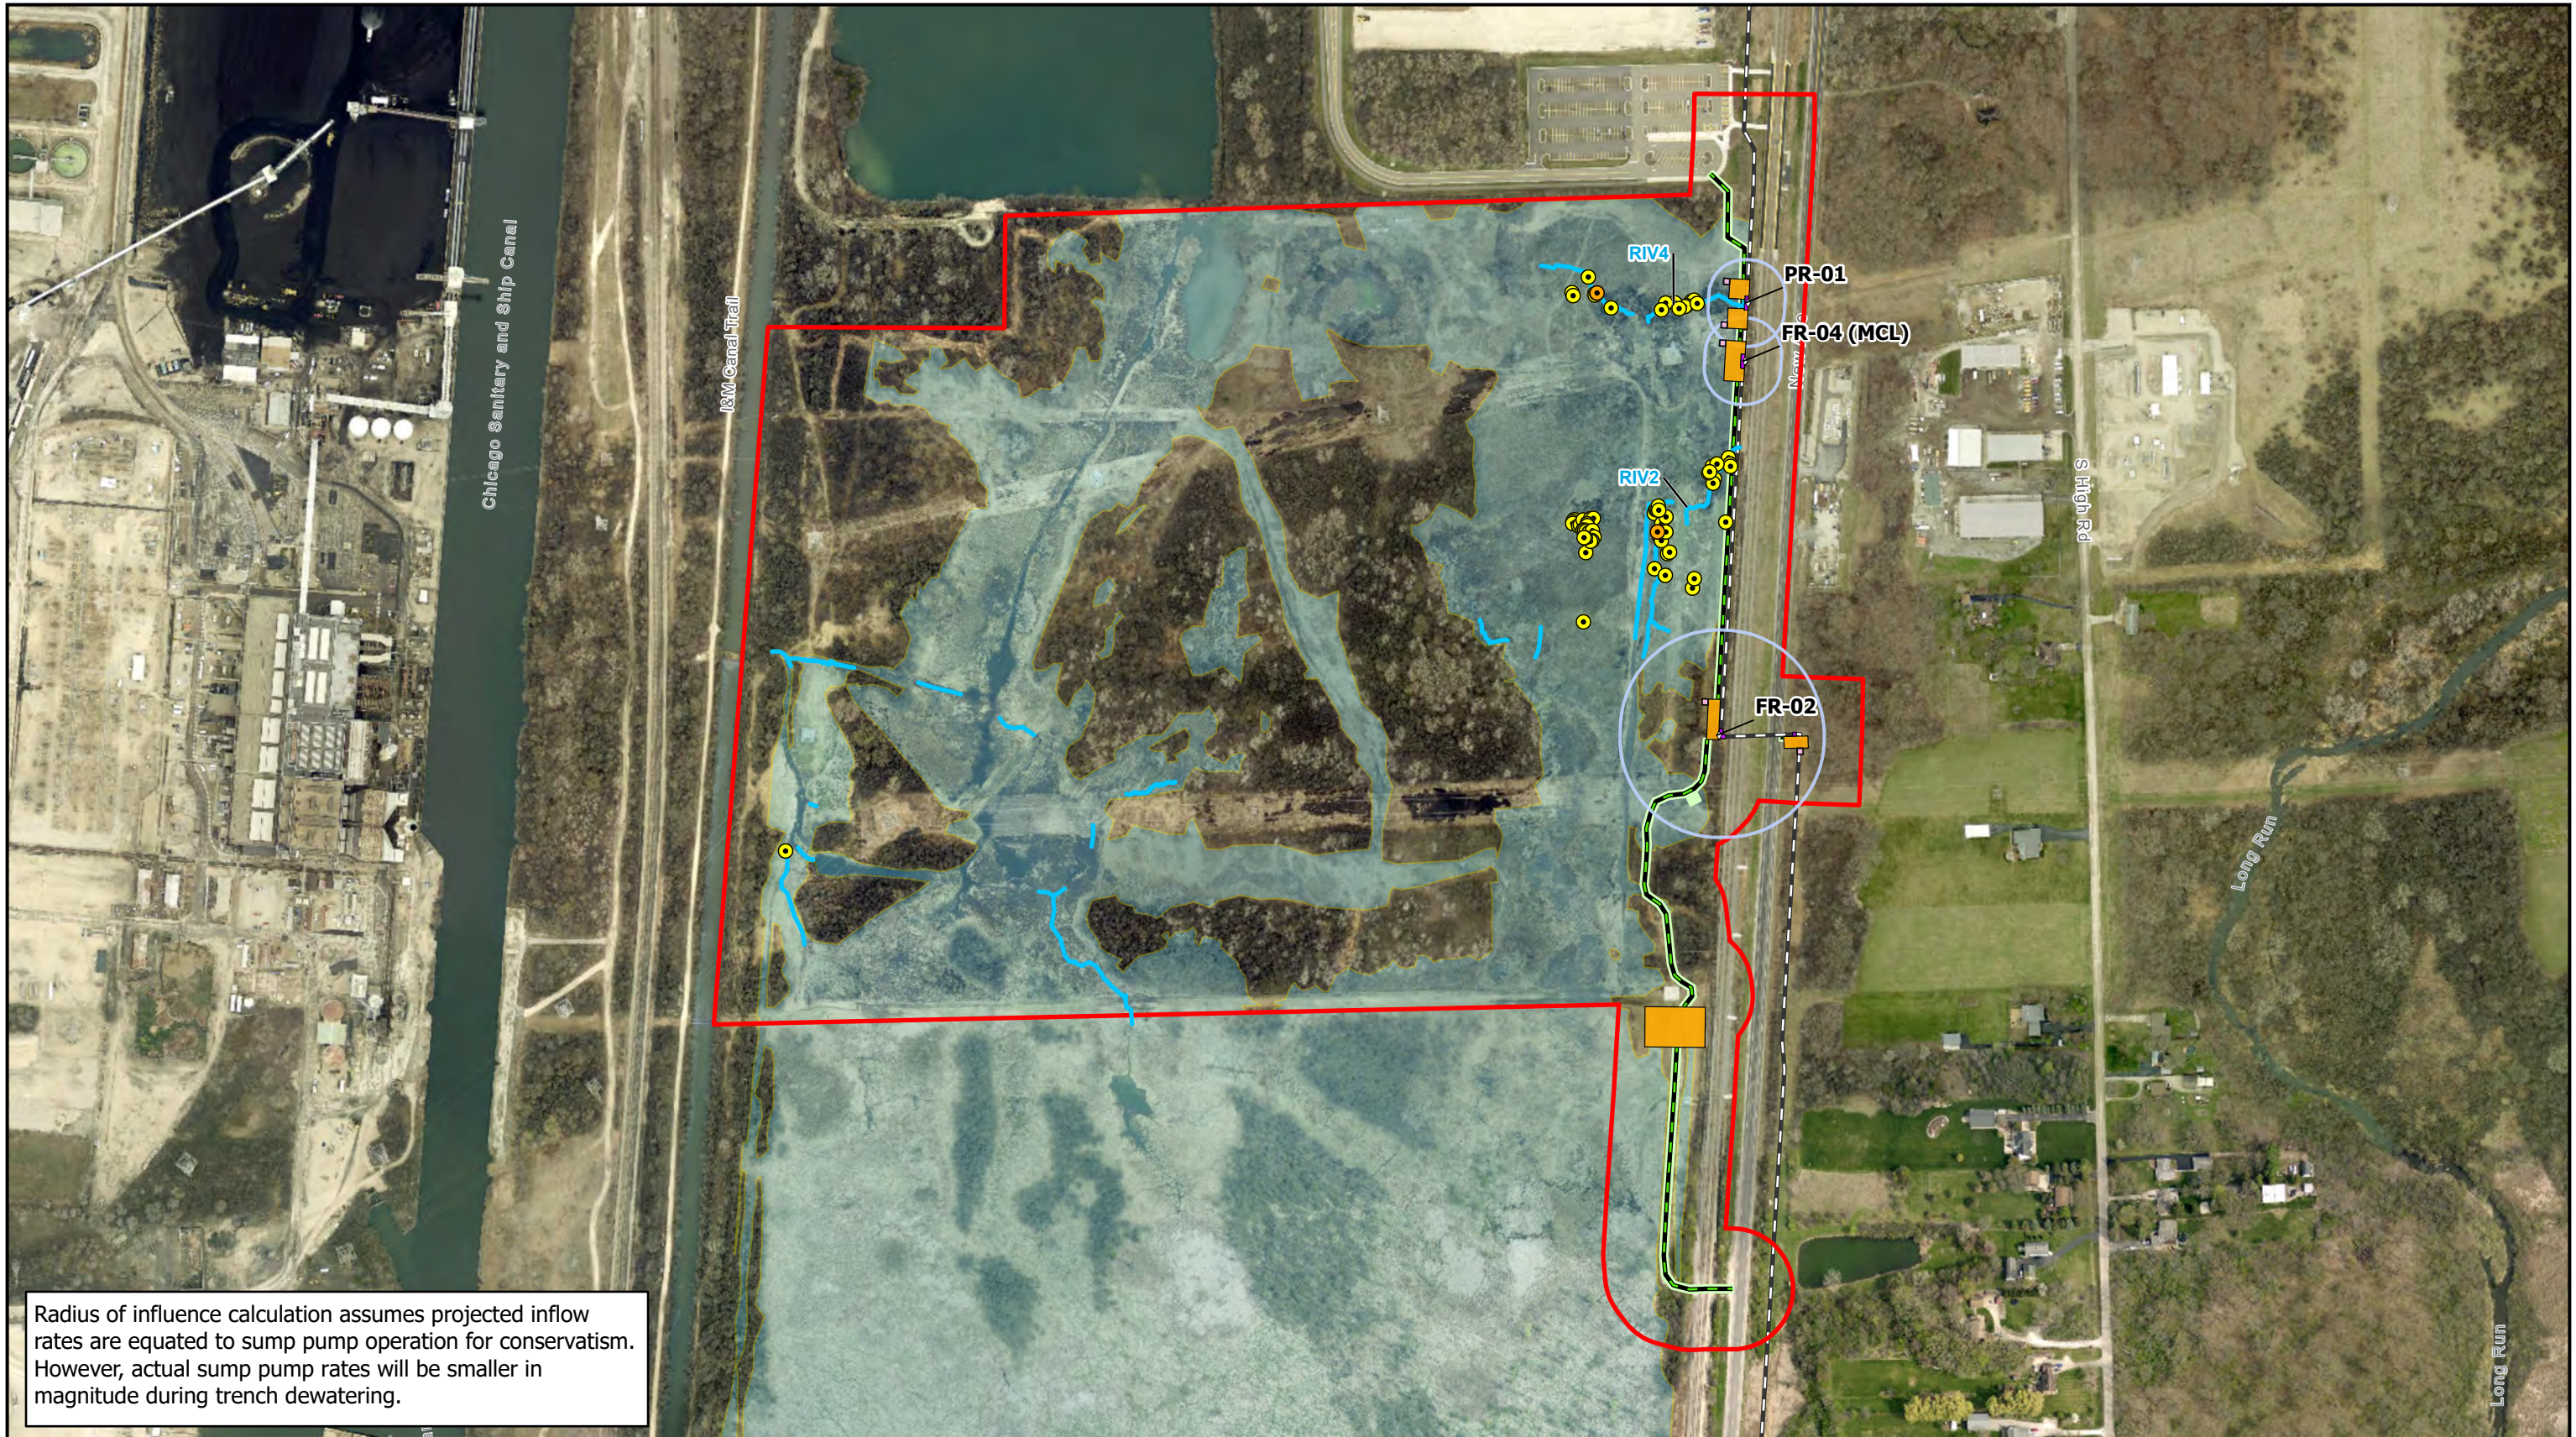
Radius of influence calculation assumes projected inflow rates are equated to sump pump operation for conservatism. However, actual sump pump rates will be smaller in magnitude during trench dewatering.
